# APPENDIX P

**Environmental and Remediation Services Inc.**

### Photograph Log

RE: Geophyical Surveys at 07-03-033-01 W5 and 08-03-033-01 W5, OLDS, ALBERTA

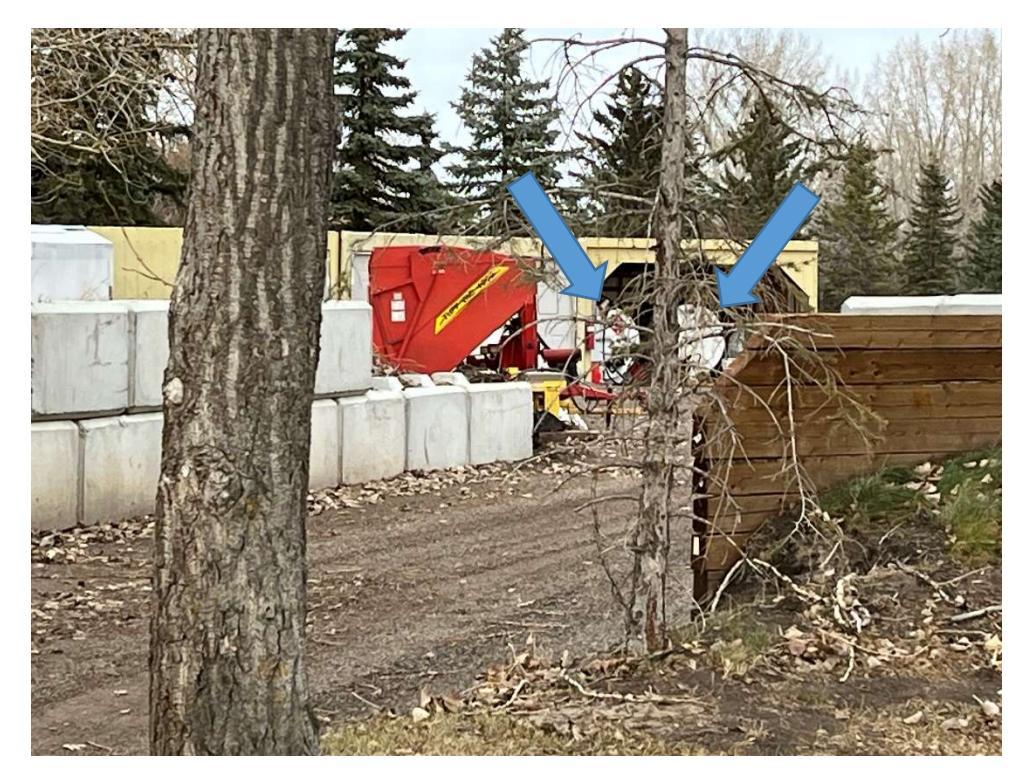
21. Close up view of the ASTs (arrows) located within one of the sea cans; photograph taken facing northwest.

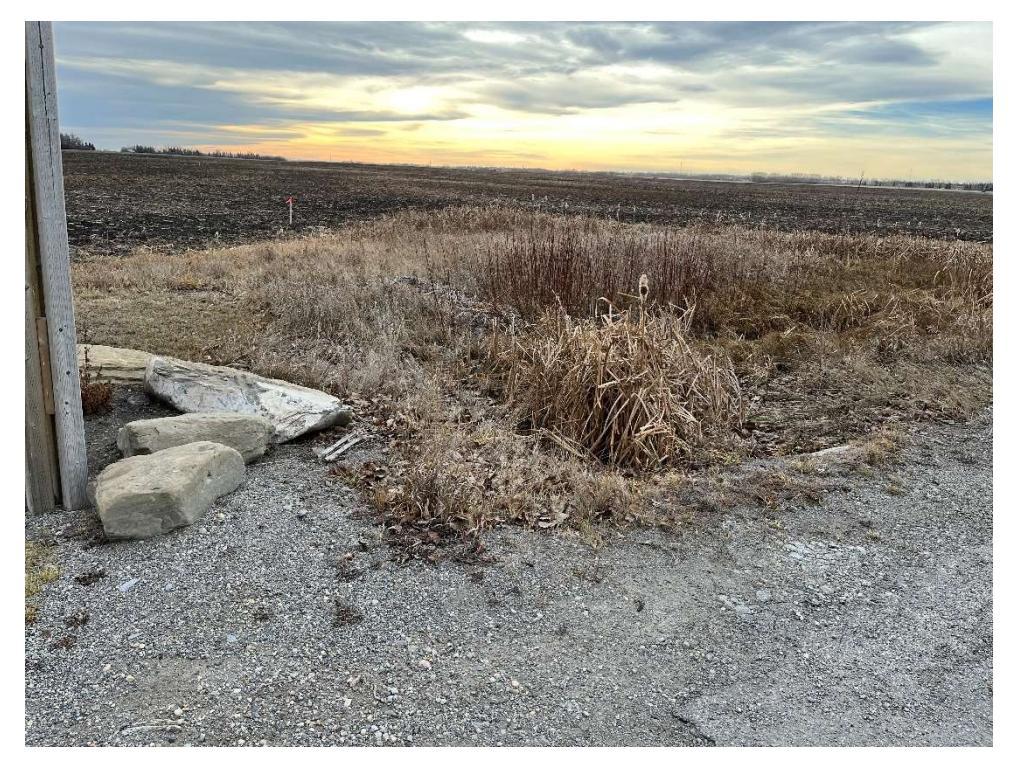
22. View of the Project Site to the south; drainage from the parking lot has created a wet area adjacent and into the Project Site.

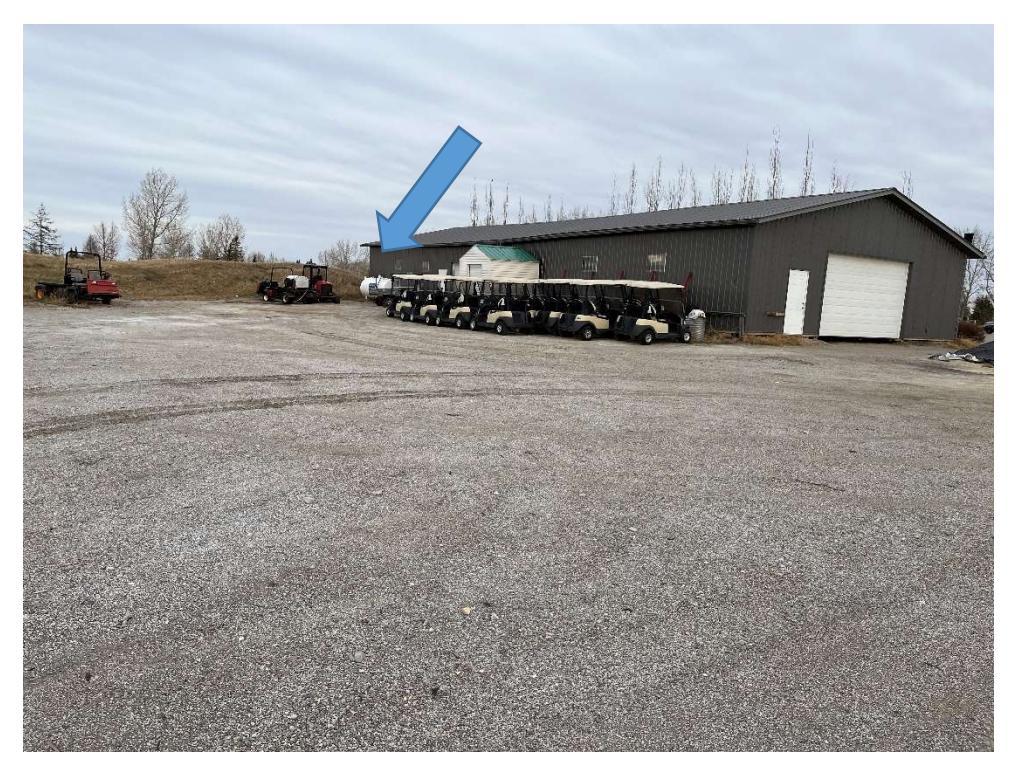
27. View of the AST (arrow) located on the west side of the battery charging building; photograph taken facing northeast.

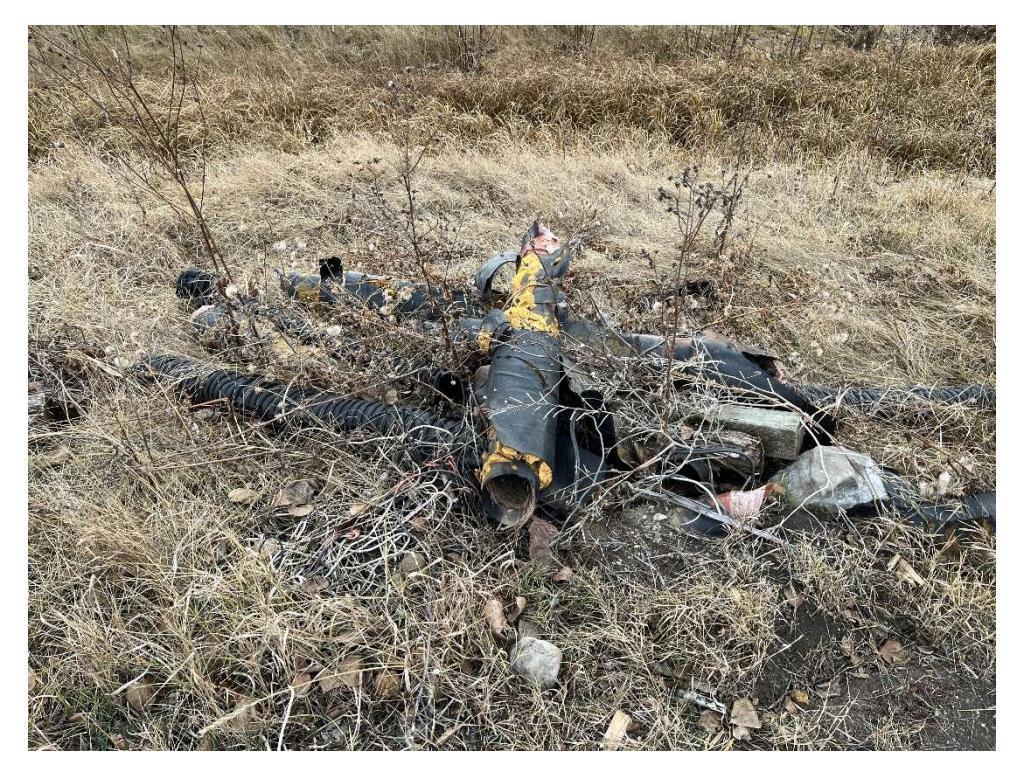
28. Debris pile north of the Project Site on the Olds Golf Course property; photograph taken facing south.

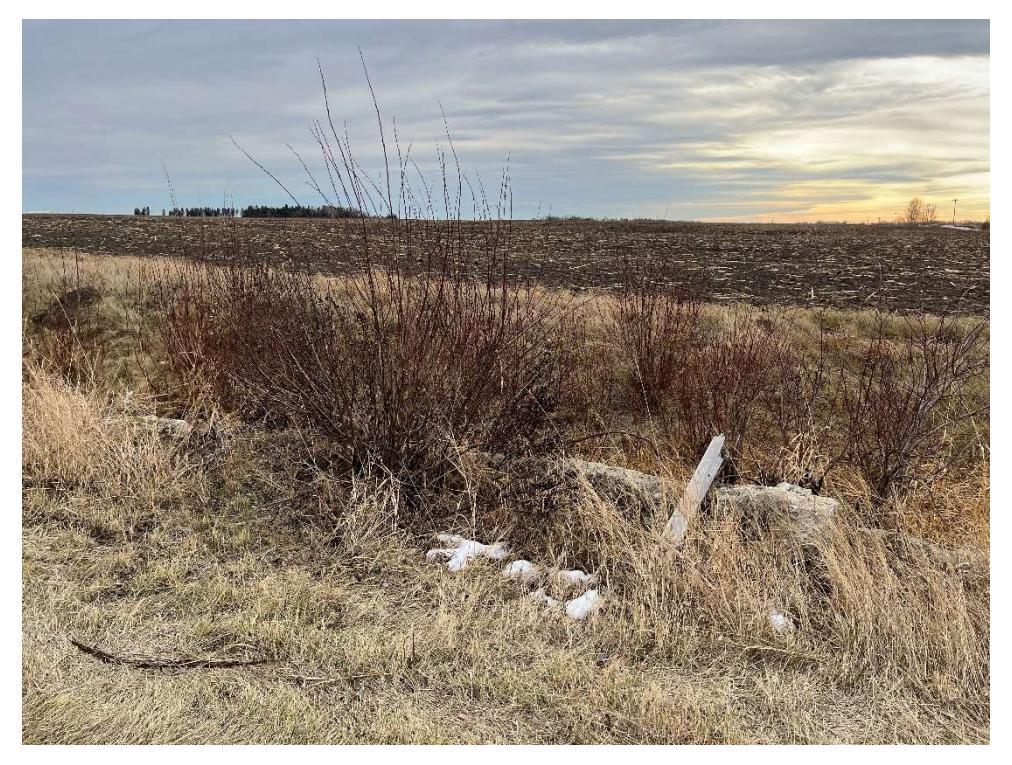
30. View of what appears to be a former concrete retaining wall, north of the Project Site; photograph taken facing southeast.

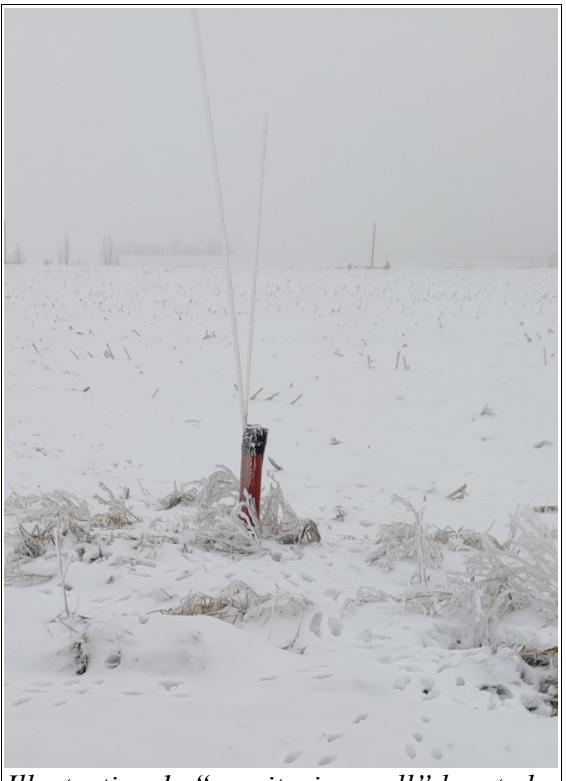
Illustration 1: "monitoring well" located with 07-03-033-01W5 (see Figure 1-3 for location)

07-03-033-01 W5 has yielded geophysical data consistent with an area that has experienced soil disturbance caused by well site drilling activity. The magnetometer data has provided a reasonably strong anomaly which coincides with the documented location of the oil well location, however the presence of "monitoring well" on site, 20 m to the northeast of the documented location, needs to be further explained as to it's function. Is it possible the "monitoring well" actually leads to the well cap? The geophysical data at 08-03-033-01 W5 provided more uniform results which suggested little subsurface disturbance in spite of the aerial imagery which indicated poor vegetation growth. The low conductivity values recorded at this location would be consistent with sandy/dry soils which may account for the dearth of vegetation. The one anomaly at UTMz11: E703339, N5742994 is deemed to be too subtle to be attributed to a buried well casing, however investigating the surface once the snow melts may be worthwhile to look for possible causes.

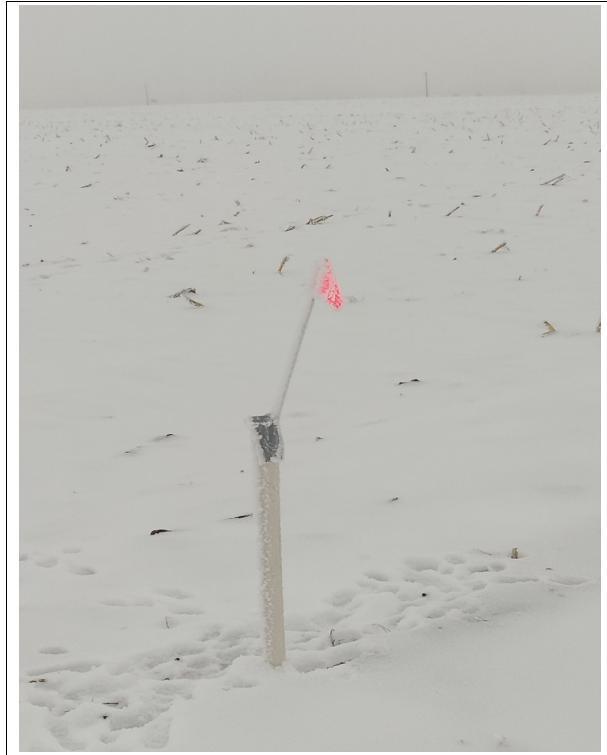
Illustration 2: 3" PVC pipe protruding from ground located within 07-03-22-01W5. (See Figures 1-3 for location)

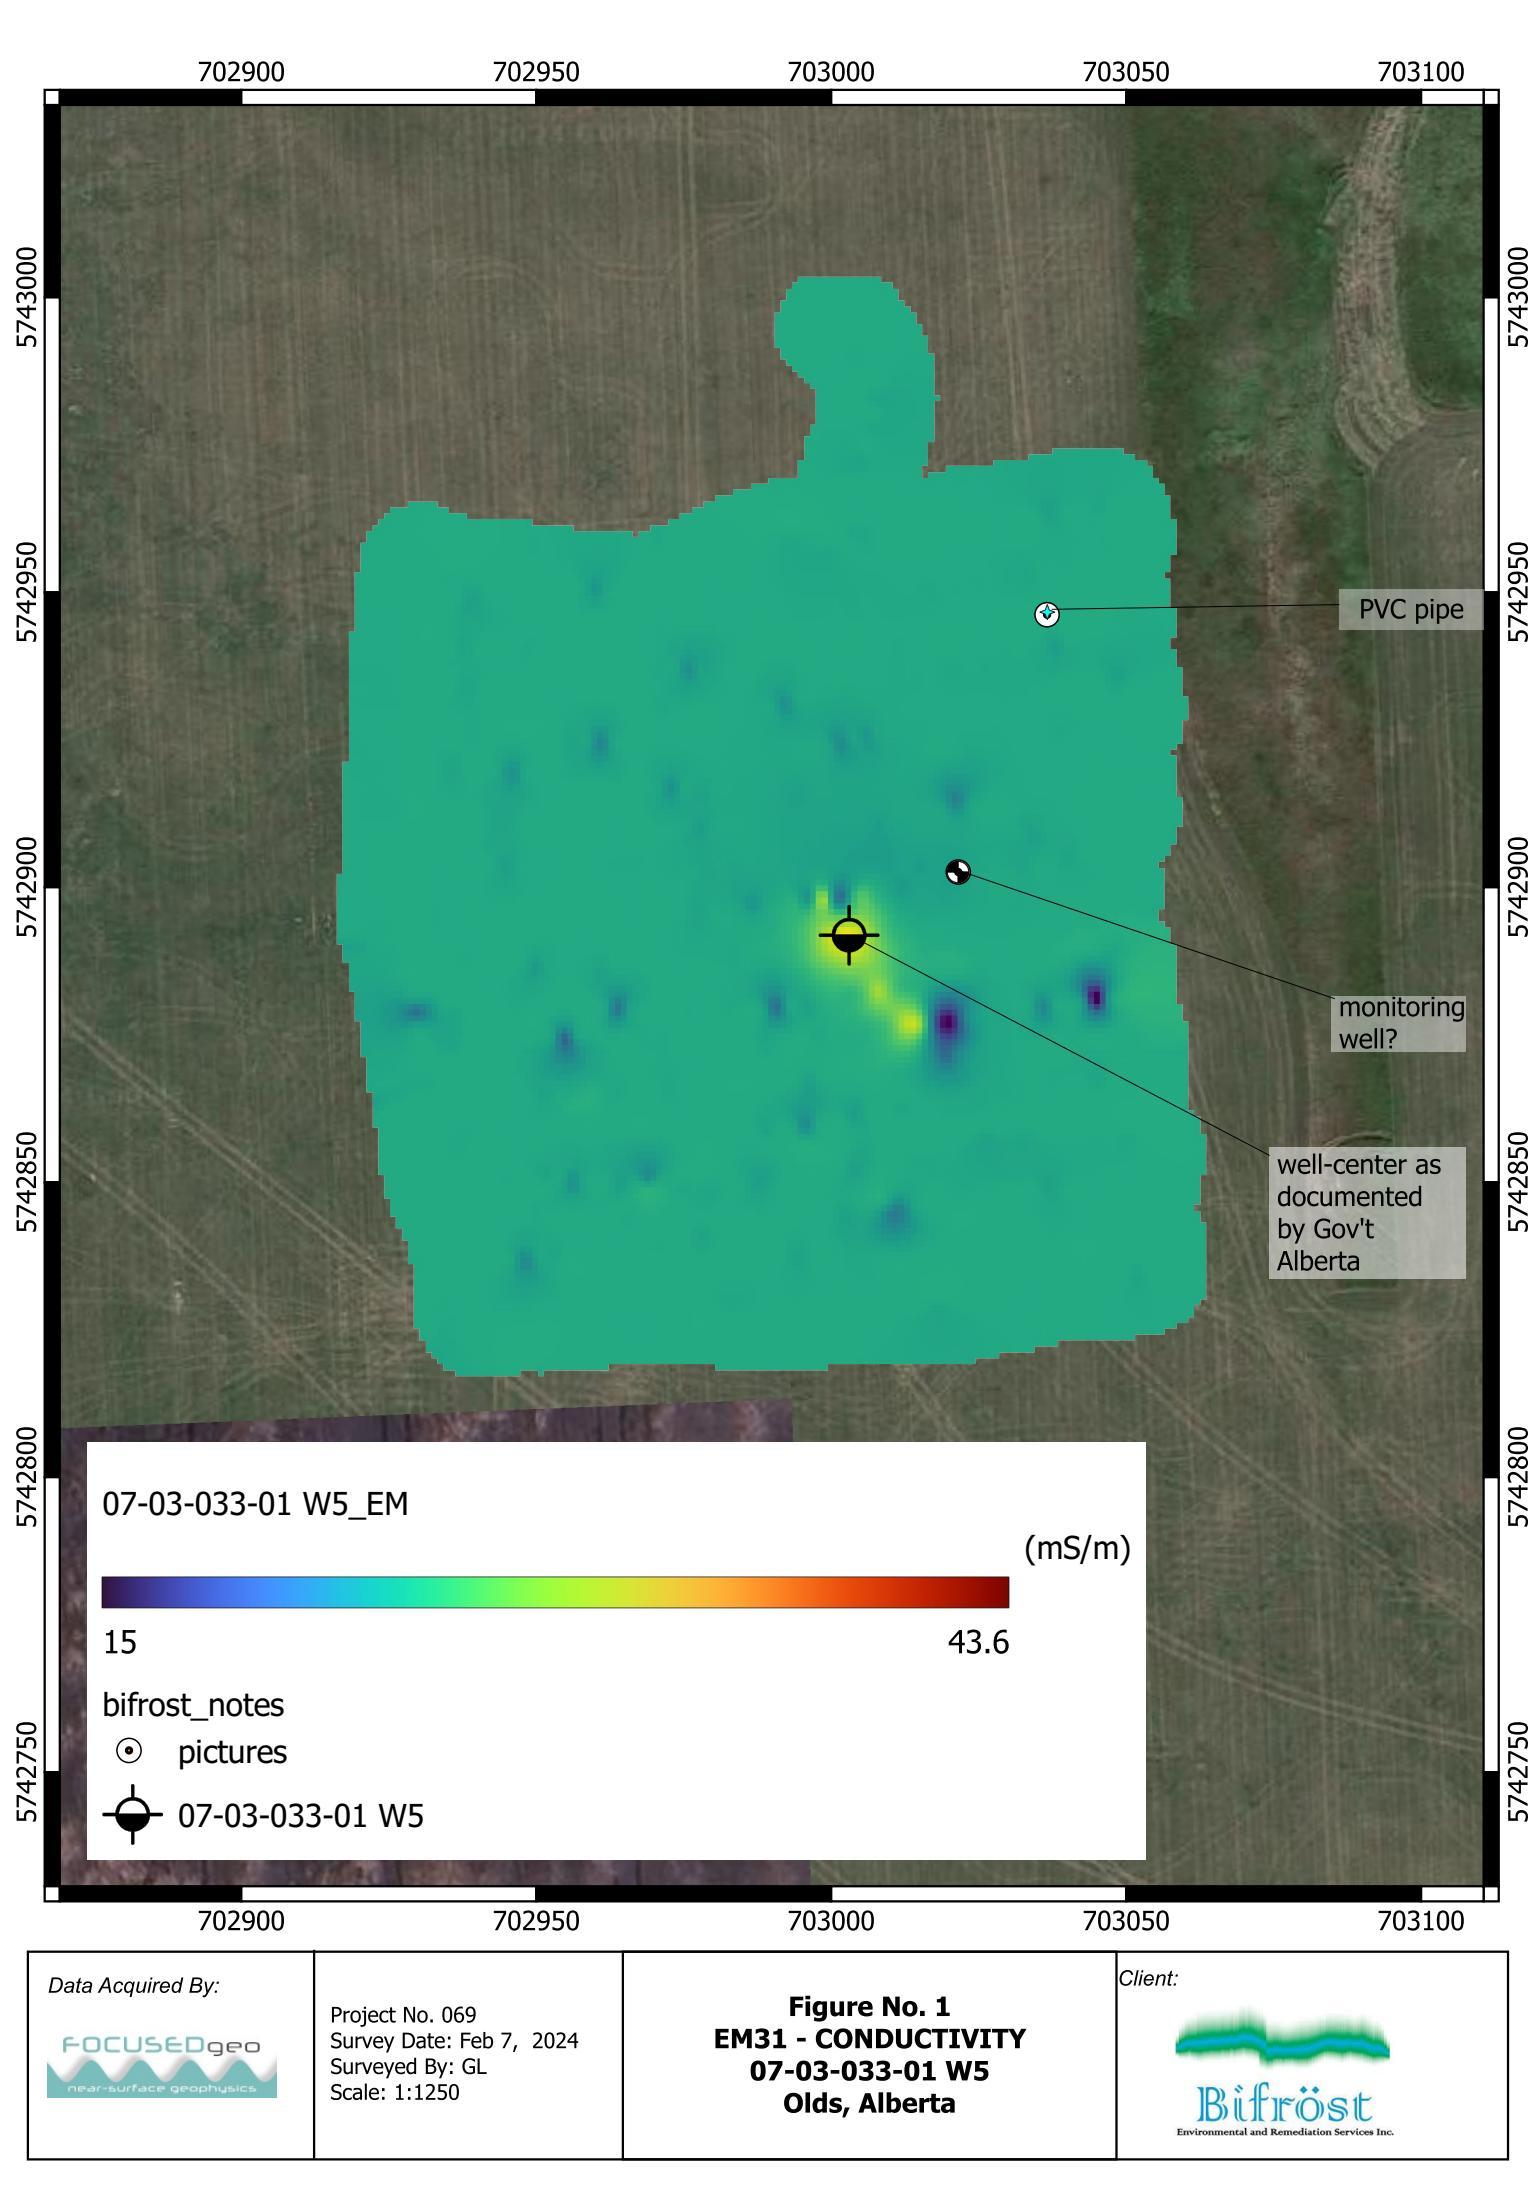
Three plots, apparent conductivity, inphase and magnetometer readings collected and extrapolated over the areas of interest, 07-03-033-01 W5 and 08-03-033-01 W5 are presented in the figures section (see below). *Figure 1: apparent conductivity for 07-03-033-01 W5* has a range of conductivity from 5 - 50 ms/m. There were two pipes located on the site and have been marked on the figure. One looked like a monitoring well with metal housing while the second was a simple 3" diameter PVC pipe protruding from the ground (see illustrations 1 and 2). *Figure 2: INPHASE response for 07-03-033-01 W5 and Figure 3: Total Magnetic Field* both display heterogeneous responses suggesting disturbed subsurface conditions while the Total Magnetic Field has an anomaly which corresponds to the location of the abandoned well as documented by the Government of Alberta. (https://extmapviewer.aer.ca/AERAbandonedWells/Index.html, well licence: 0072245) *Figure No. 4 – 6* provide the conductivity, inphase and magnetic field data collected over *08-03-033-01 W5* with the apparent conductivity ranging from 7- 18 mS/m and the total magnetic field ranging from 55638 –

N5742994 which appears on all three plots, however the sensitivity of each of these instruments when in uniform site conditions should be taken into account when ascribing the cause.

55657 nT vs 50538 - 58867 nT at 07-03-033-01 W5. There is an anomaly at UTMz11: E703339,
