## APPENDIX C: LABORATORY TEST RESULTS

# Laboratory Analysis Summary Sheet

Phase One  
Environmental Site Assessment  
Of  
W ½ Sec 2, SE Sec 2 , SE Sec 3 Twp 33 Rge 1 W5M  
Olds, Alberta

Phase Two  
Environmental Site Assessment  
Of  
SE Sec 2 and SE Sec 3 Twp 33 Rge 1 W5M  
Olds, Alberta

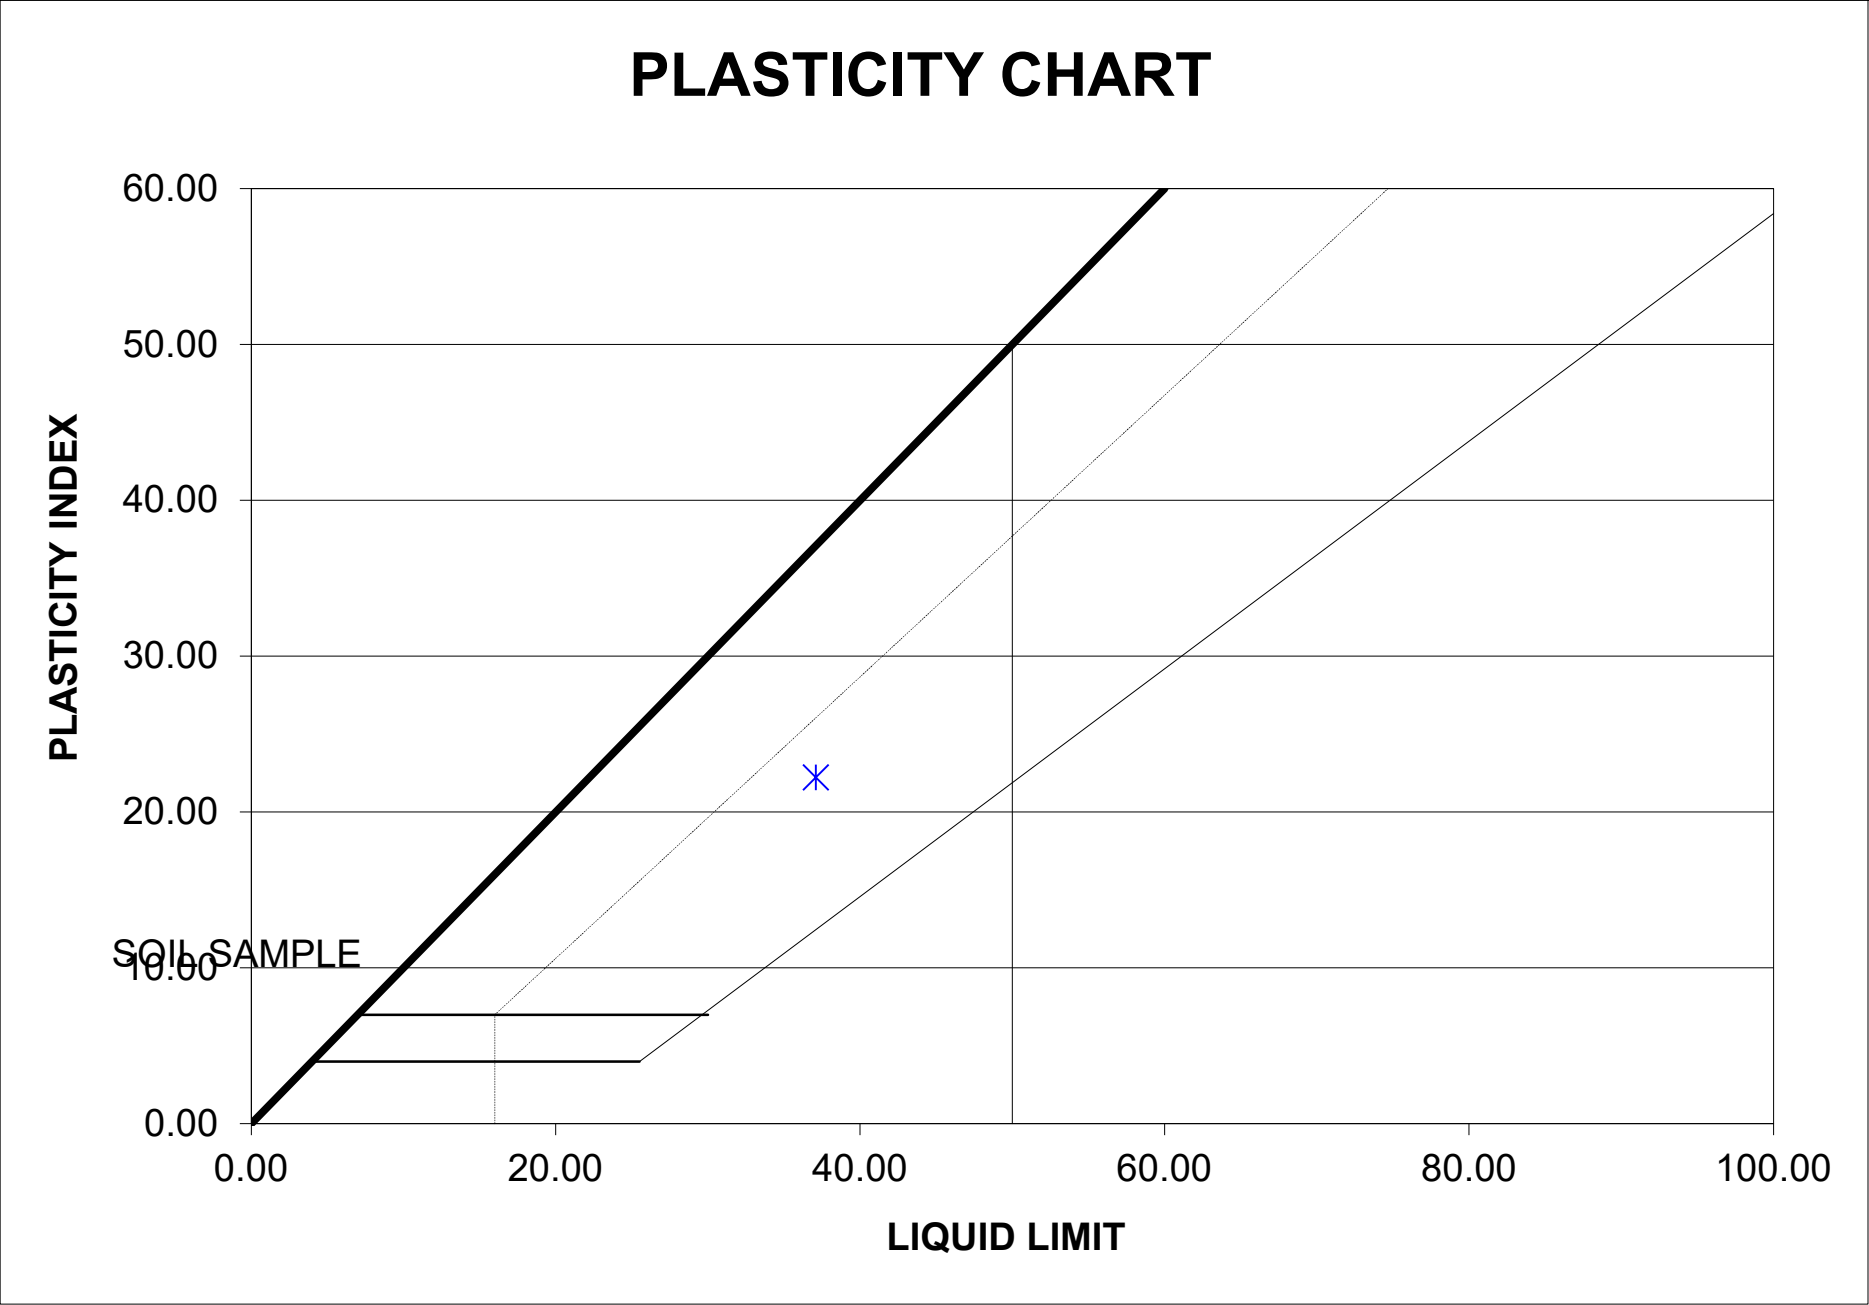
## LIQUID LIMIT DETERMINATION

TEST NUMBER	1	2	3		
TIN NUMBER	A8	6	A7		
NUMBER OF BLOWS (LIQUID LIMIT)	42	30	26		
WET WEIGHT	33.8	33.3	33.6		
DRY WEIGHT	28.7	28.2	28.4		
MOISTURE	5.1	5.1	5.2		
TIN WEIGHT	14	14.1	14.3		
SOIL WEIGHT	14.7	14.1	14.1		
WATER CONTENT	34.7%	36.2%	36.9%

TEST NUMBER	1	2			
TIN NUMBER	16	11			
WET WEIGHT	24.9	25			
DRY WEIGHT	23.5	23.6			
MOISTURE	1.4	1.4			
TIN WEIGHT	14.2	14.1			
SOIL WEIGHT	9.3	9.5			
WATER CONTENT	15.1%	14.7%

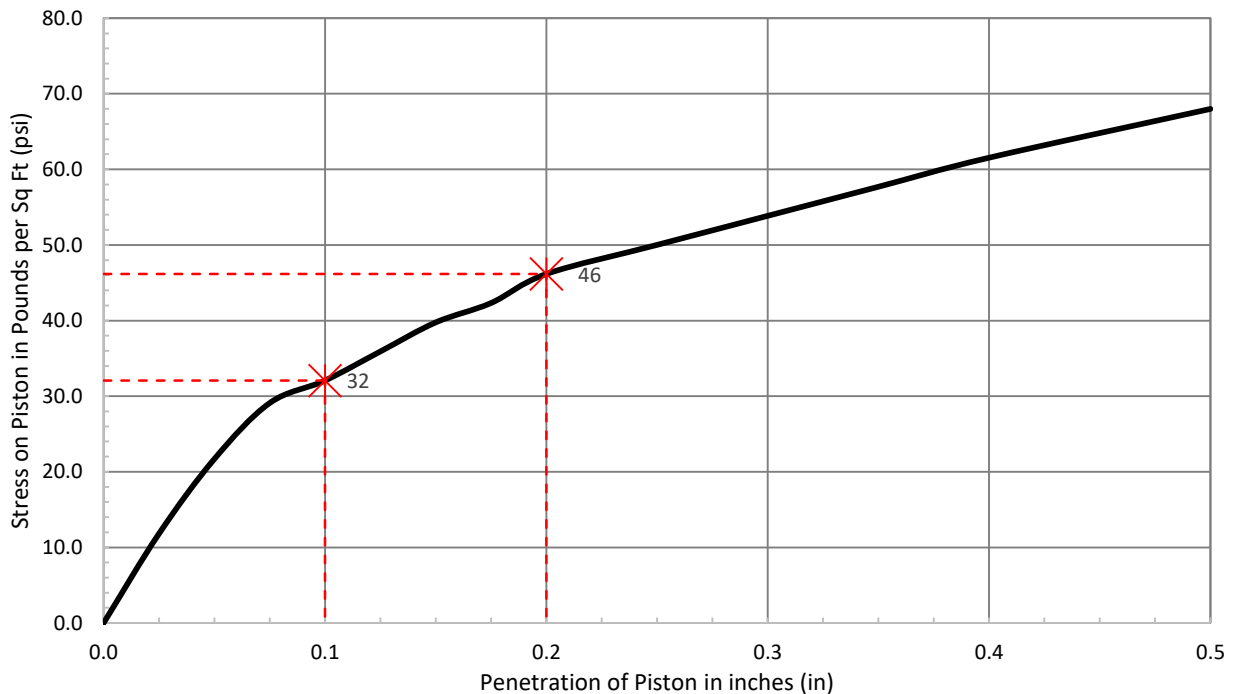
# California Bearing Ratio

Type of Preparation	Standard ASTM D698	Sample Preparation	Soaked
Maximum Dry Density	1892 kg/m <sup>3</sup>	Soaking time	96 hrs
Optimum Moisture Content	13.3 %	Top 1 Inch Soaked Moisture	17.3 %
Compacted Dry Density	1880 kg/m <sup>3</sup>	Bottom 1 Inch Soaked Moisture	16.6 %
Compacted Moisture Content	15.5 %	Average Soaked Moisture	16.5 %
Percent Compaction	99.4 %	Mass of Surcharge	13.6 kg

Corrected Penetration (in.)	Standard Load of Crushed Stone (psi)	Corrected Load (psi)	CBR (%)
0.100	1000	32	<b>3.2</b>
0.200	1500	46	<b>3.1</b>

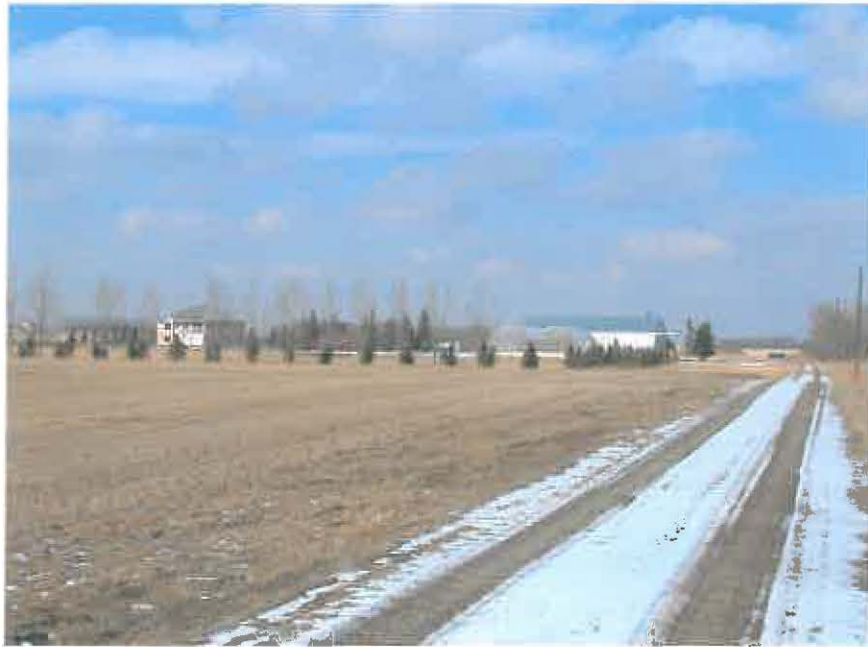
**Photo One – View of SW2 Farmstead Looking Northwest**

Because the farmstead buildings on the SW2 were built after 1995 they are not likely to contain any regulated substances such as lead-based paints, asbestos containing construction materials and fluorescent light fixtures with PCB's in their ballast. An AST was observed on the SW2 farmstead but no above ground fuel storage tanks (ASTs) were observed on the SE2, they may have been on that property in the past. When the AST on the SW2 is no longer required and when the SE2 is redeveloped, should any stained or noxious soil be encountered during site development then Base Property Consultants Ltd. should be contacted to determine the appropriate use of this material. No obvious signs of uncontrolled dumping were observed during the site reconnaissance. Historical air photos show a surface disturbance at the northwest corner of the SW 2 in 1988 and 1990. No obvious sign of this disturbance was noted during the site reconnaissance. Should any buried foreign materials, buried organic soil, stained or noxious smelling soil be encountered during site development then Base Property Consultants Ltd. should be contacted to conduct further investigation.

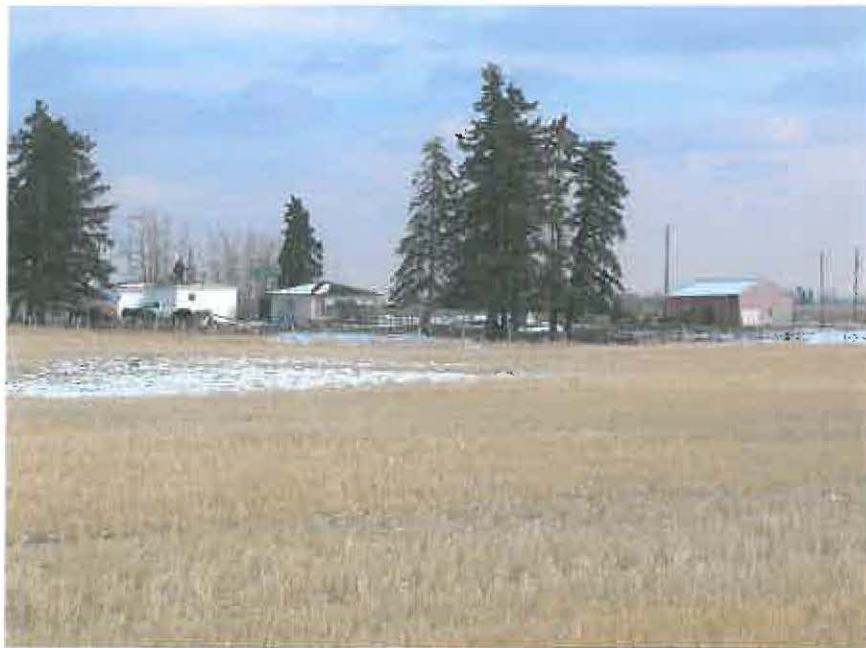
**Photo Two – View of SE2 Farmstead Looking Southeast**

The farmstead on the SE2 is serviced by a septic system and water well. No obvious signs of refuse or burn pits was observed. The detached garage was not available for viewing. No obvious signs of the former farmstead buildings was observed. The service station to the southeast of the SE2 has underground storage tanks (UST's).

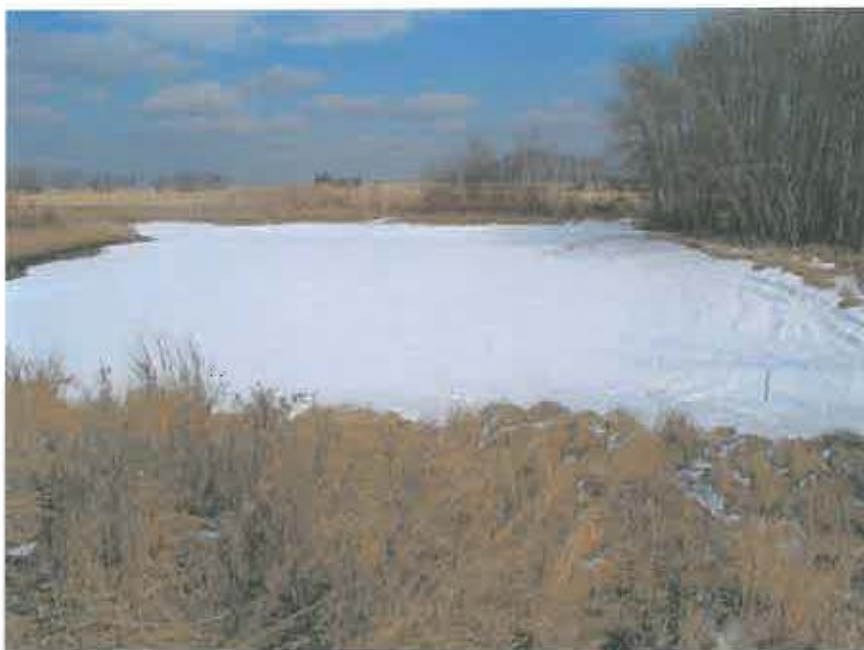
Photo Four – View of Dugout in NW2 Wood Lot Looking East

willows) in the southeast corner of the NW2 and planted trees, shrubs and grass around the farmsteads in the SW2 and SE2. The wood lot has a dugout at its southeast corner. There were no obvious signs of uncontrolled dumping observed on the property.
