# APPENDIX W

## Methane Surveys

Methane Survey - LSD 7

Dir. 079 Gas Migration Test Prepared For: Peyto Exploration & Development Corp.

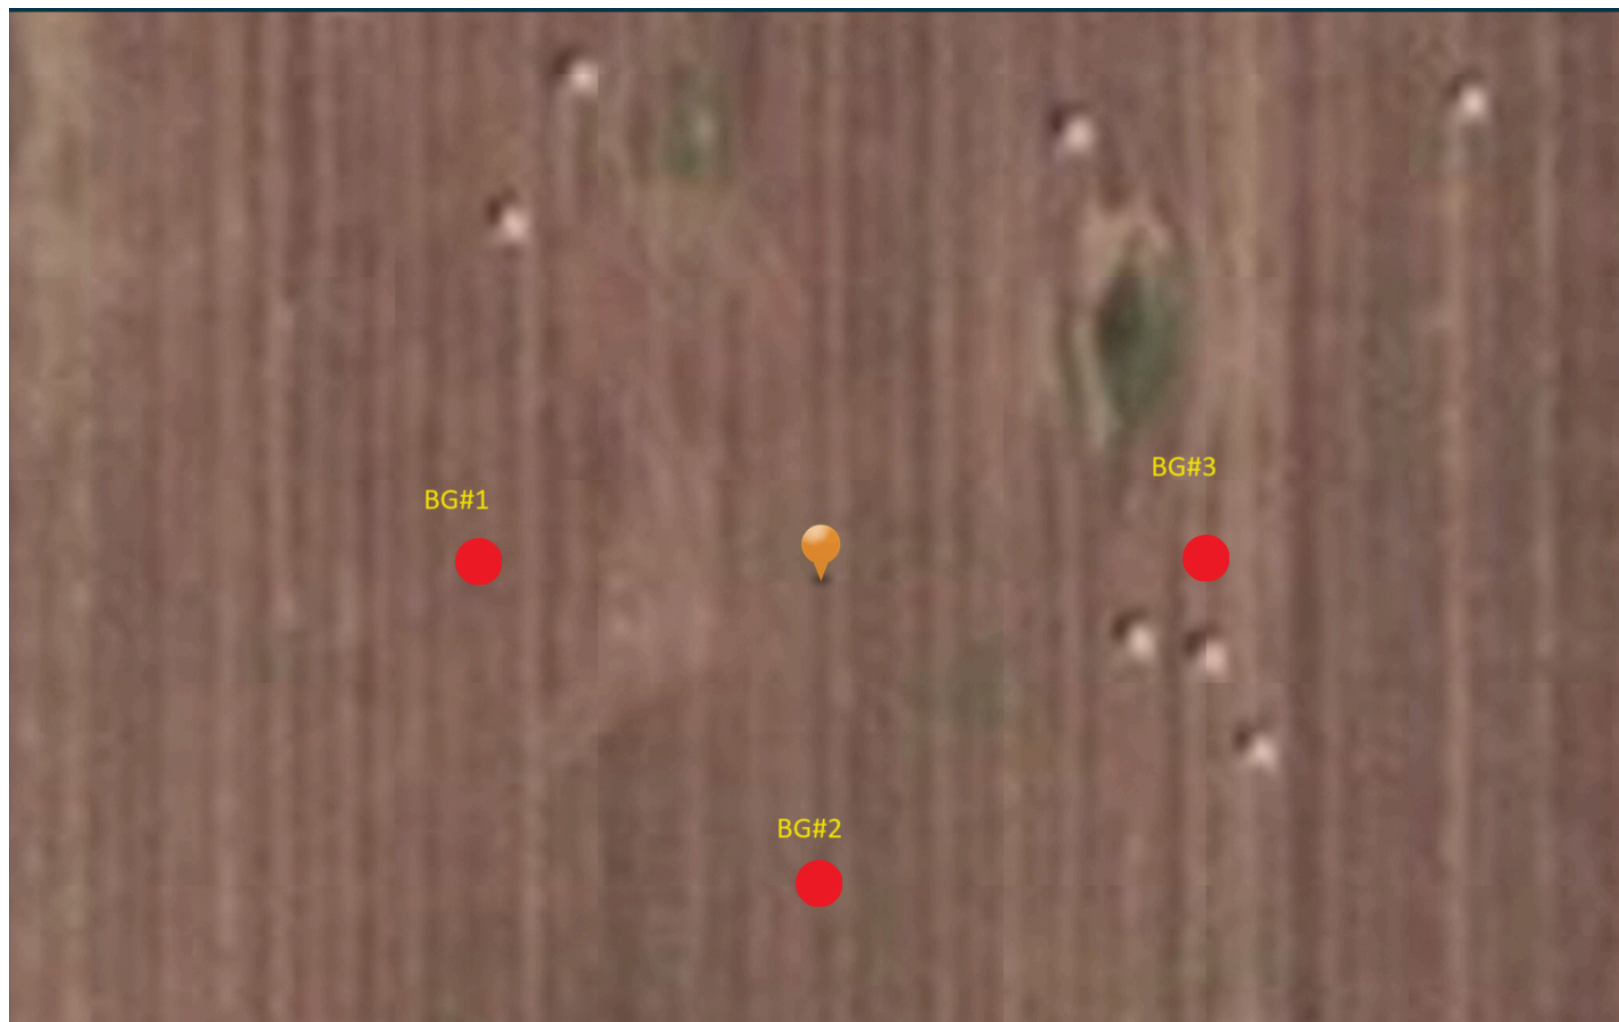
**00/07-03-033-01W5/0**

**Date: May 11, 2024**    Nearest permanent structure from well centre: 306m north

**Well Centre:** 51.800064, -114.055921

**Background 1 (BG1):** 30.0 meters West of Well Centre. (51.800063, -114.056361) 5ppm methane

**Background 2 (BG2):** 30.0 meters South of Well Centre. (51.799791, -114.055924) 3ppm methane

**Background 3 (BG3):** 30.0 meters East of Well Centre. (51.800043, -114.055475) 2ppm methane

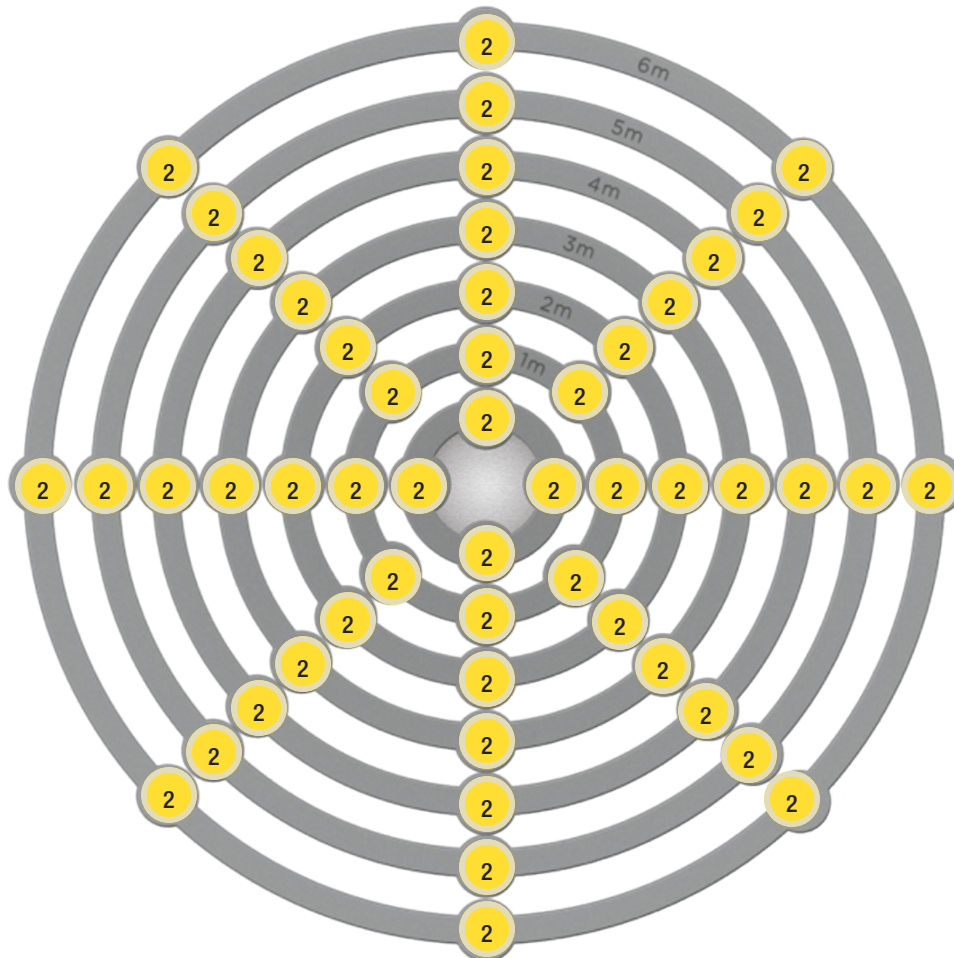
### Surface Soil Gas Data

PEAK READING	
2	ppm
< 0.05	% V
< 1	% LEL

Surface soil gas data is collected using DSA's patent pending surface contact GM test method. The method is recognized and accepted by regulatory bodies where DSA operates. For more information about our procedures and/or intellectual property, contact [legal@doullsite.com](mailto:legal@doullsite.com).

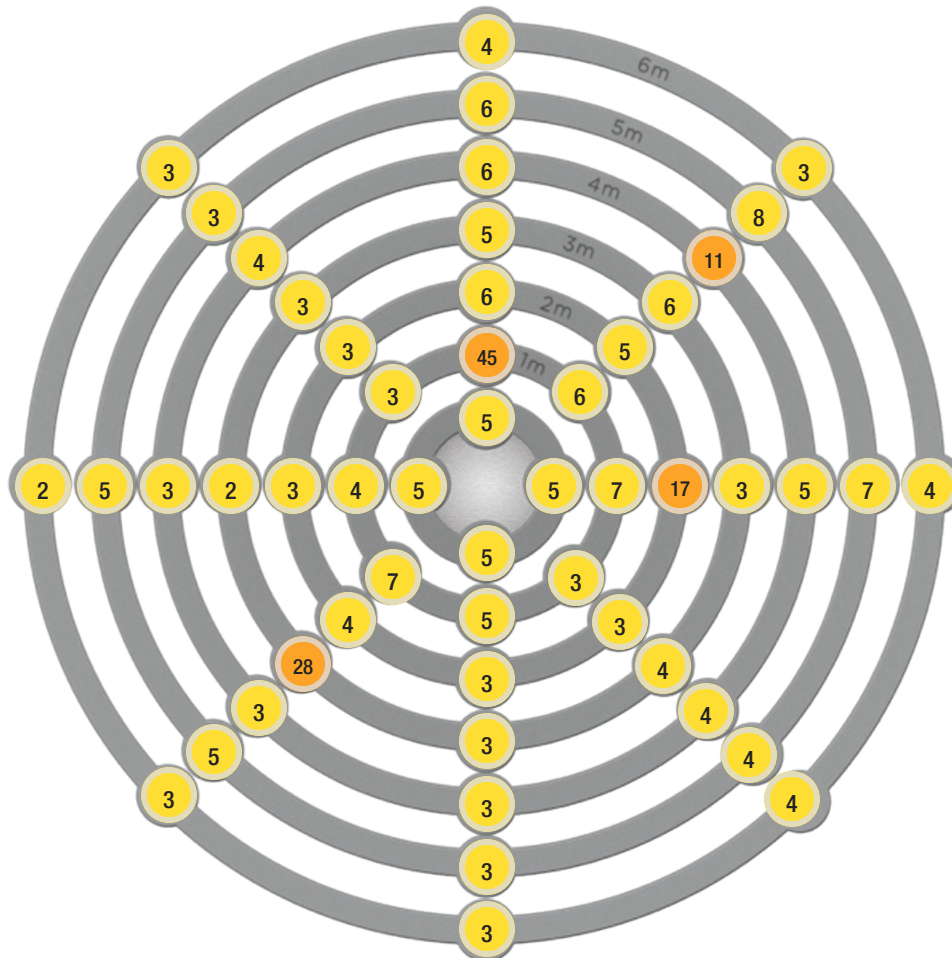
### Subsurface Soil Gas Data

PEAK READING	
45	ppm
< 0.05	% V
< 1	% LEL

Subsurface soil gas data is collected by DSA's subsurface GM test method. The method is recognized and accepted by regulatory bodies where DSA operates. For more information about our procedures and/or intellectual property, contact [legal@doullsite.com](mailto:legal@doullsite.com).

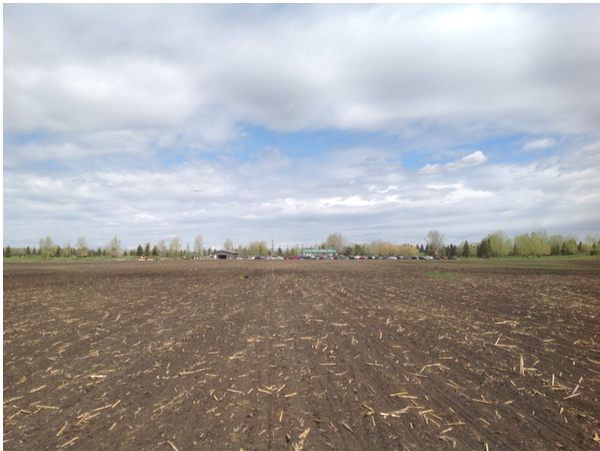
Background sample 2 (30m, 3ppm, south)

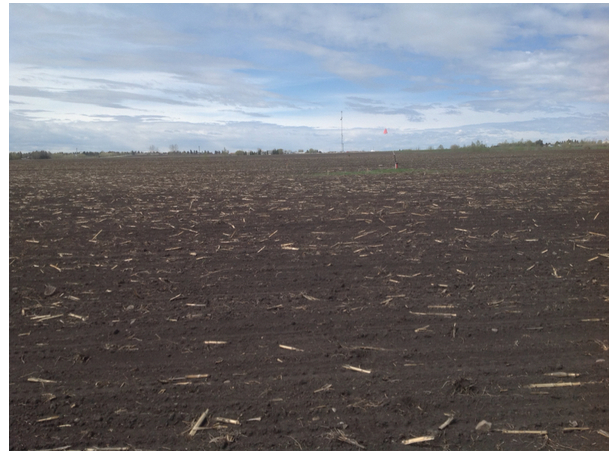
Background reading 3 (30m, east, 2 ppm)

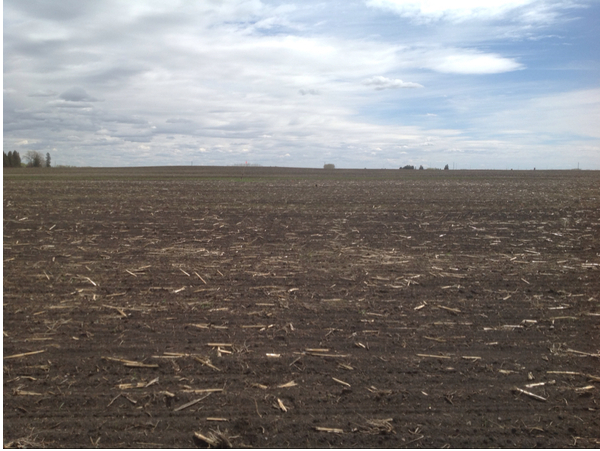
Background sample 1 (30m ,5ppm, west)

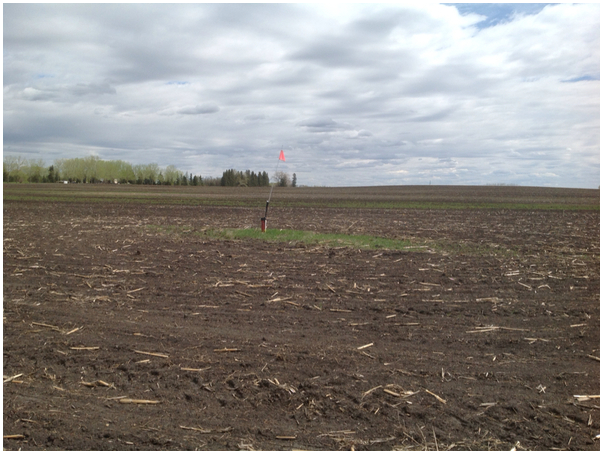
Pipe to east

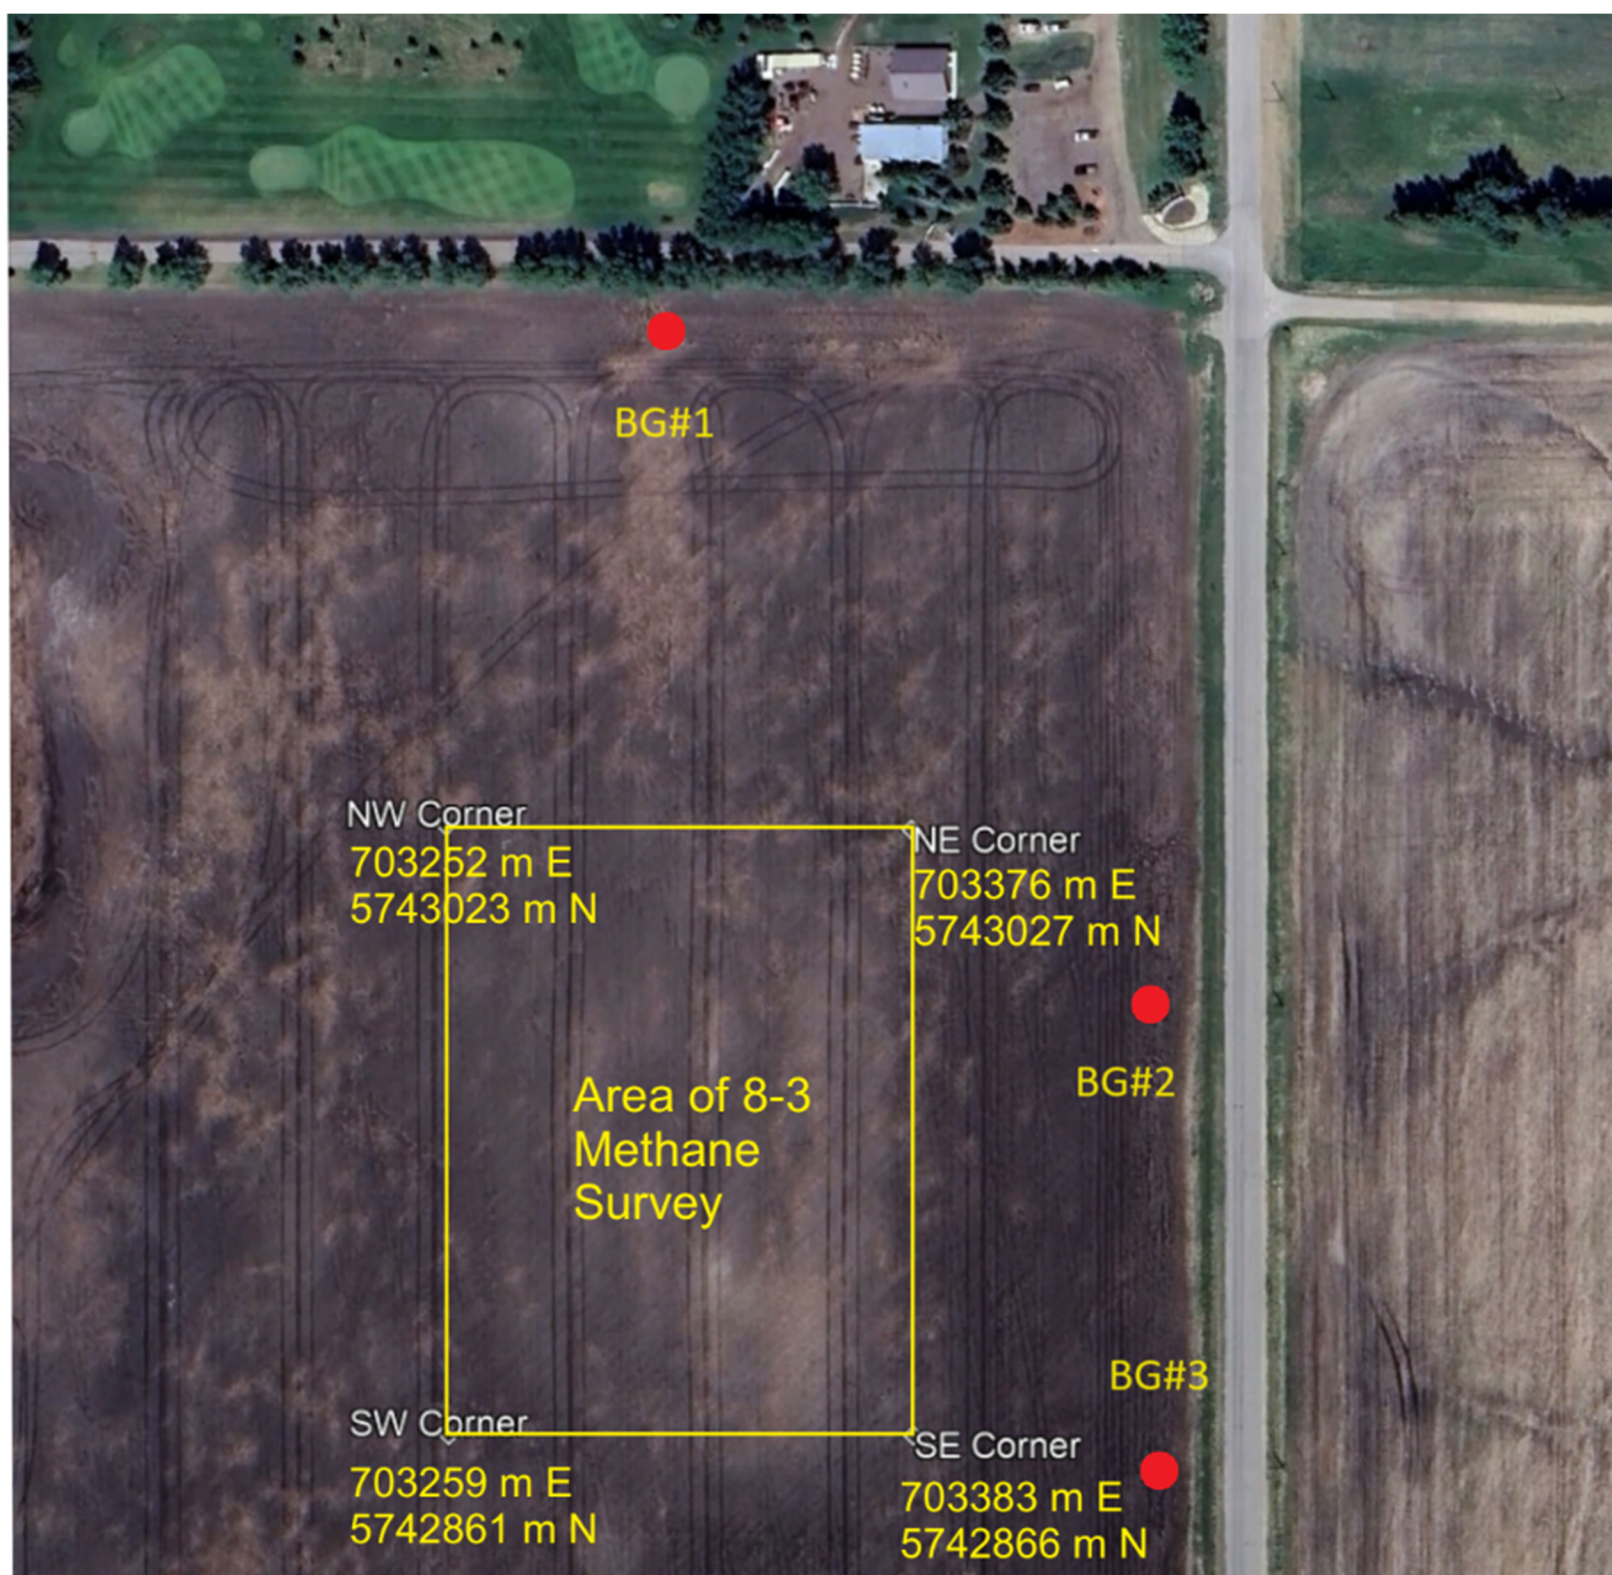
00/08-03-033-01W5/0

**Date: May 11, 2024** Nearest permanent structure from center point: ~310m north

**Centre:** 51.800064, -114.055921

**Background 1 (BG1):** (51.802283, -114.051224) 2ppm methane

**Background 2 (BG2):** (51.800653, -114.049236) 2ppm methane

**Background 3 (BG3):** (51.799539, -114.049225) 2ppm methane

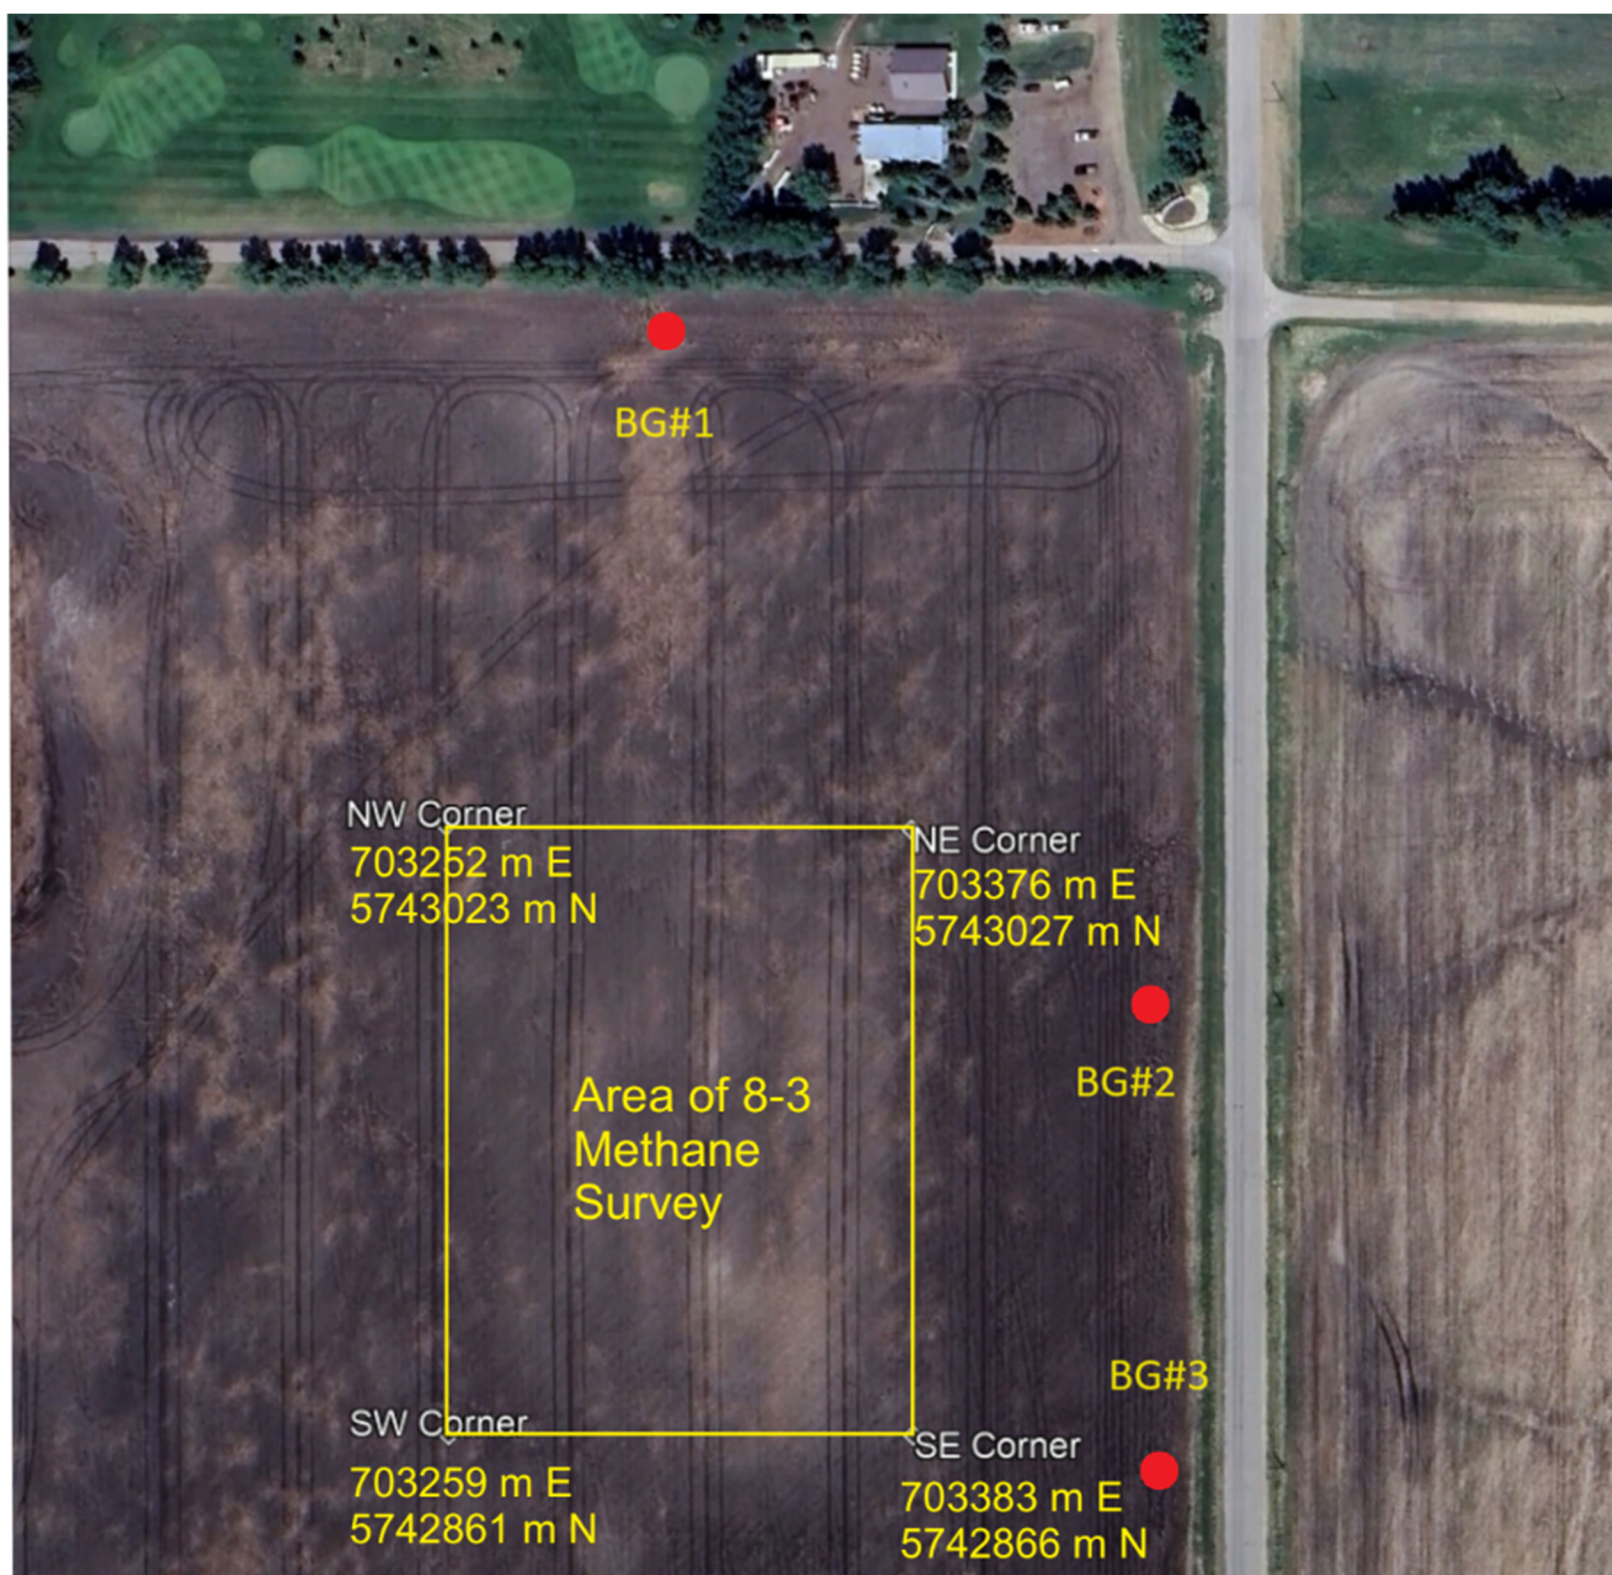
00/08-03-033-01W5/0

**Date: May 11, 2024** Nearest permanent structure from center point: ~310m north

**Centre:** 51.800064, -114.055921

**Background 1 (BG1):** (51.802283, -114.051224) 2ppm methane

**Background 2 (BG2):** (51.800653, -114.049236) 2ppm methane

**Background 3 (BG3):** (51.799539, -114.049225) 2ppm methane

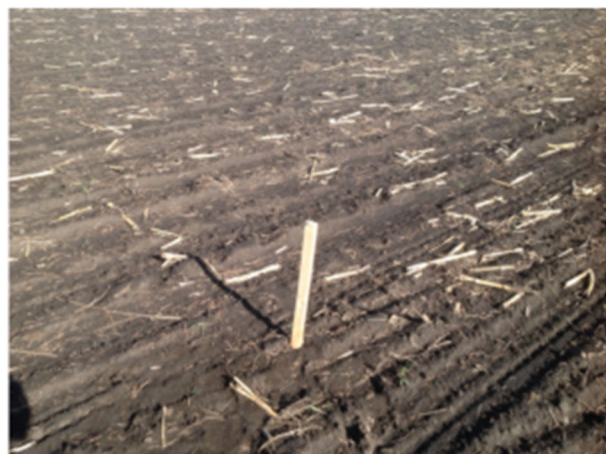
Gps centre
