**Water Course Setback Determination**

**Business Park Development - NE section of 24-29-01 WM5**

Project #: 2208-07

October 2022

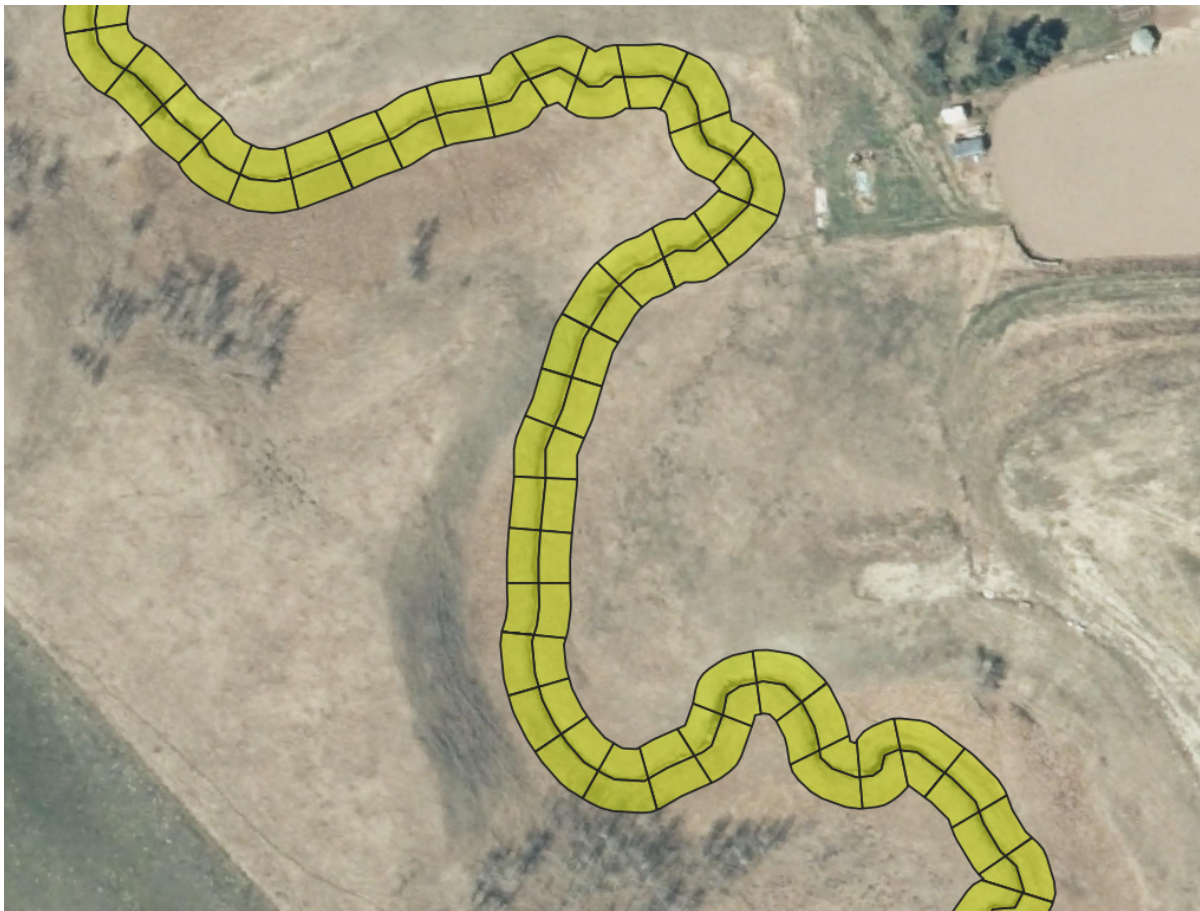
**Figure 3** Segmentation of the 6m stream buffer for calculation of average slope percentages.

Per the riparian setback requirements, a 6m buffer was generated around the stream bank. In addition, along the length of the stream, at 10 m intervals, lines running perpendicular to the stream were generated. Using the stream course (i.e., the center of the buffer) and these perpendicular lines, the 6m stream buffer was segmented ([Figure 3](#)). Within each of these segments, the average slope was calculated. These averages were derived using 1x1m resolution slope raster data<sup>2</sup>, and measured in percentage units. For each of these segments, a buffer (originating from the stream) was generated based on the following criteria (Government of Alberta 2012):
