**Phase I Environmental Site Assessment**  
**NE – 24 – 29 – 01W5M**  
**LINC: 0019163583**  
**Mountain View County**

Appin Developments Inc.

May 27, 2026

File No: 2025-2551

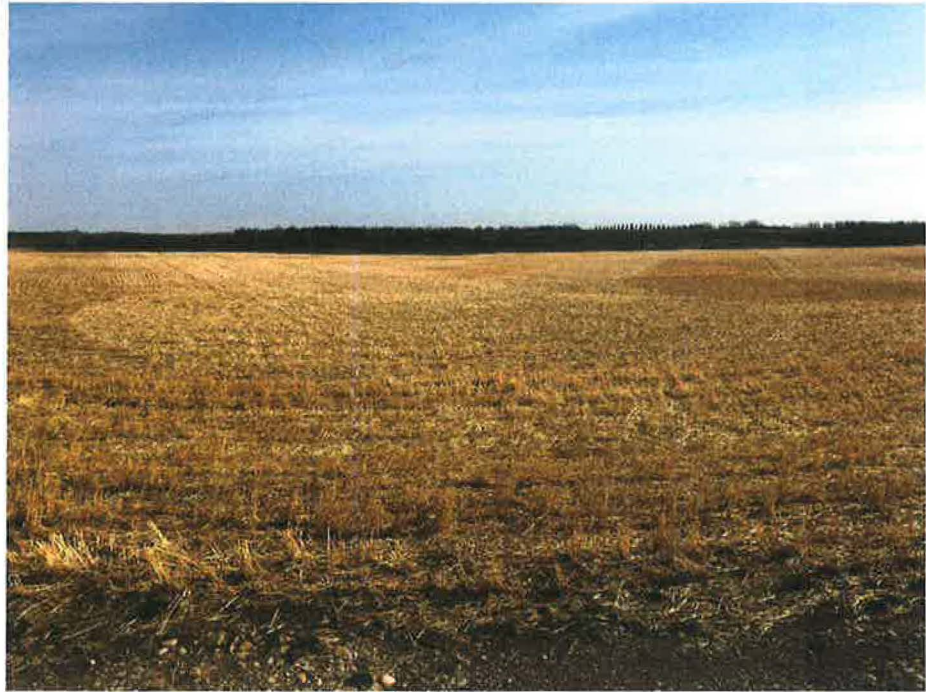
Photo 1: Looking northeast towards the Site from the southwest corner of the Site. Showing cropped agricultural land with former gravel operation visible in the distance.

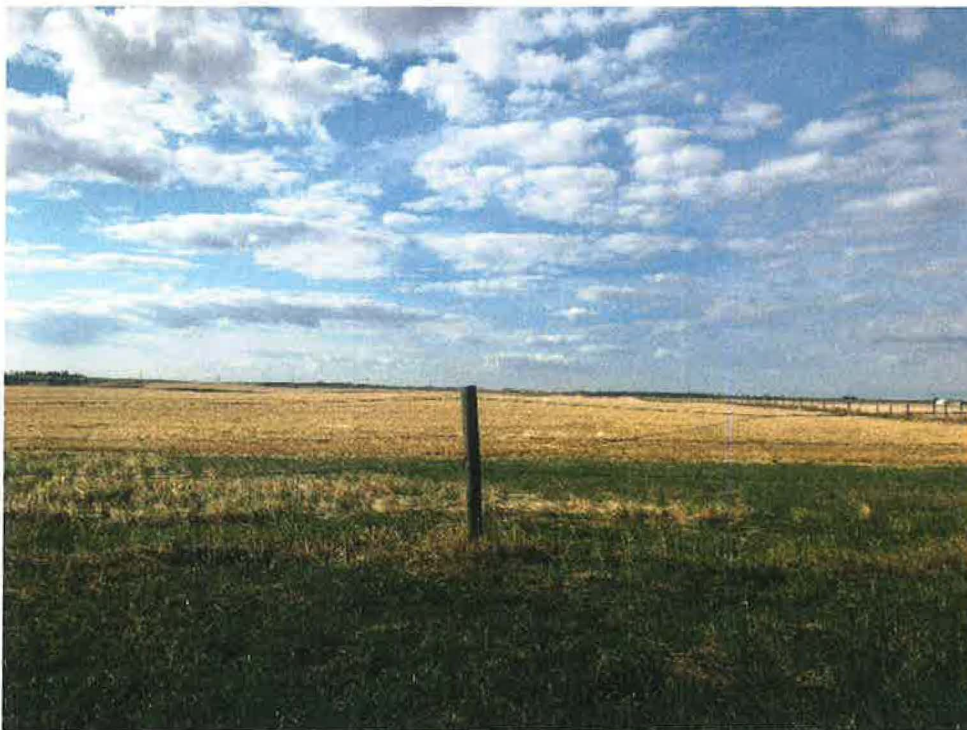
Photo 2: Looking south from the southwest corner of the Site towards the adjacent property. Shows the Site is fenced towards the south with land use to the south consisting of a similar agricultural cropland

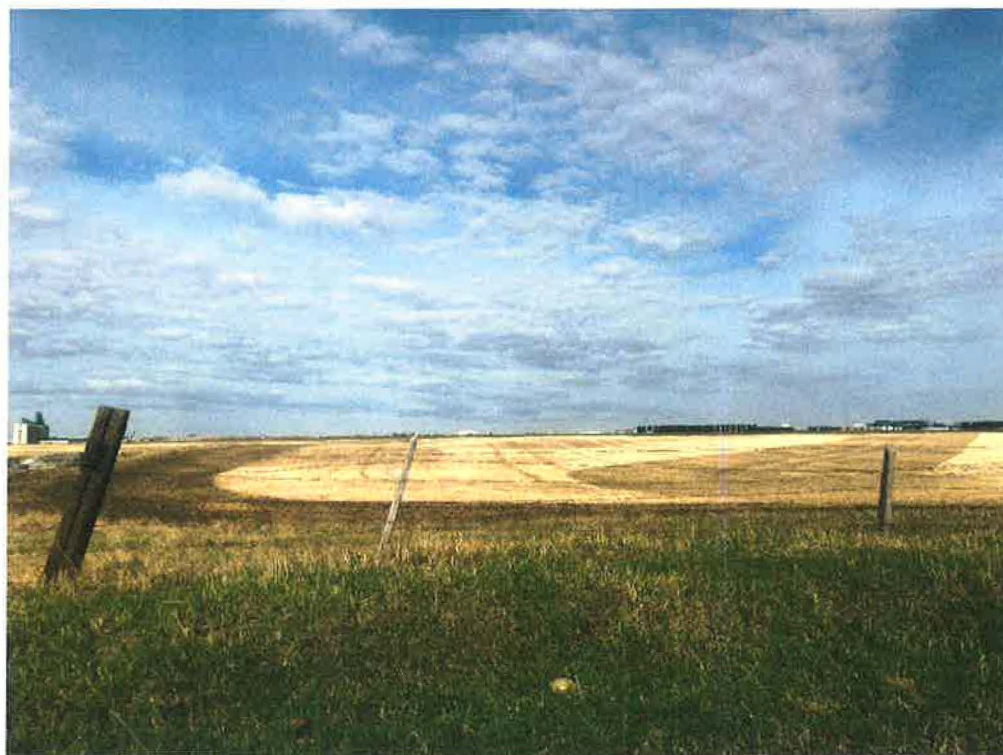
Photo 3: Looking towards the adjacent western property from the southwest corner of the Site. The adjacent west property is separated from the Site by a fence and consists of similar agricultural cropland.

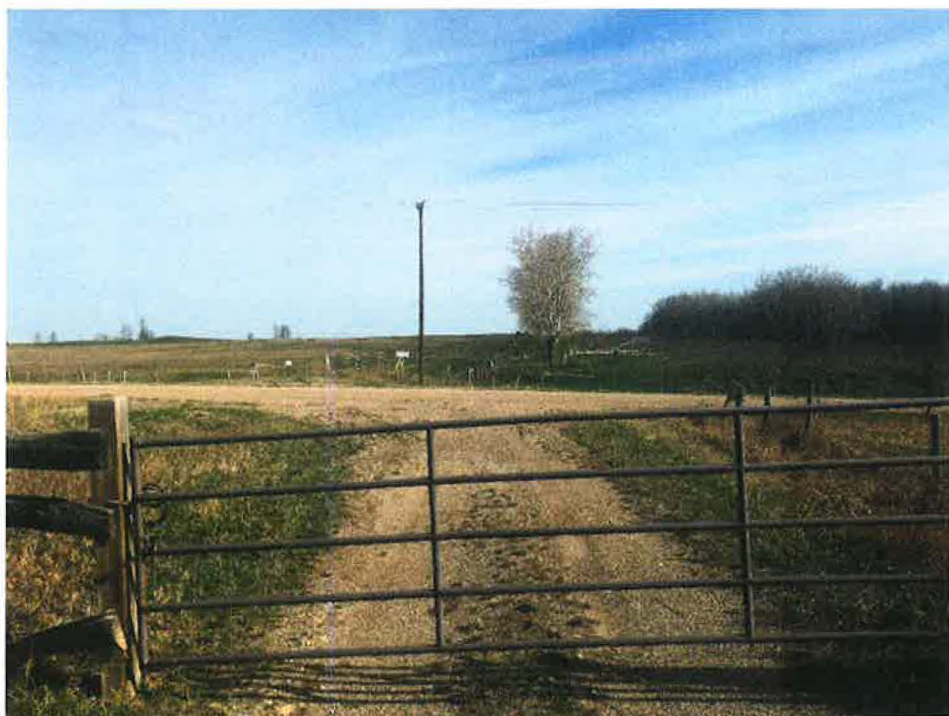
Photo 5: Looking southwest at the adjacent western agricultural property from the northwest corner of the Site. Showing fence line running along the boundary between the Site and adjacent western property.

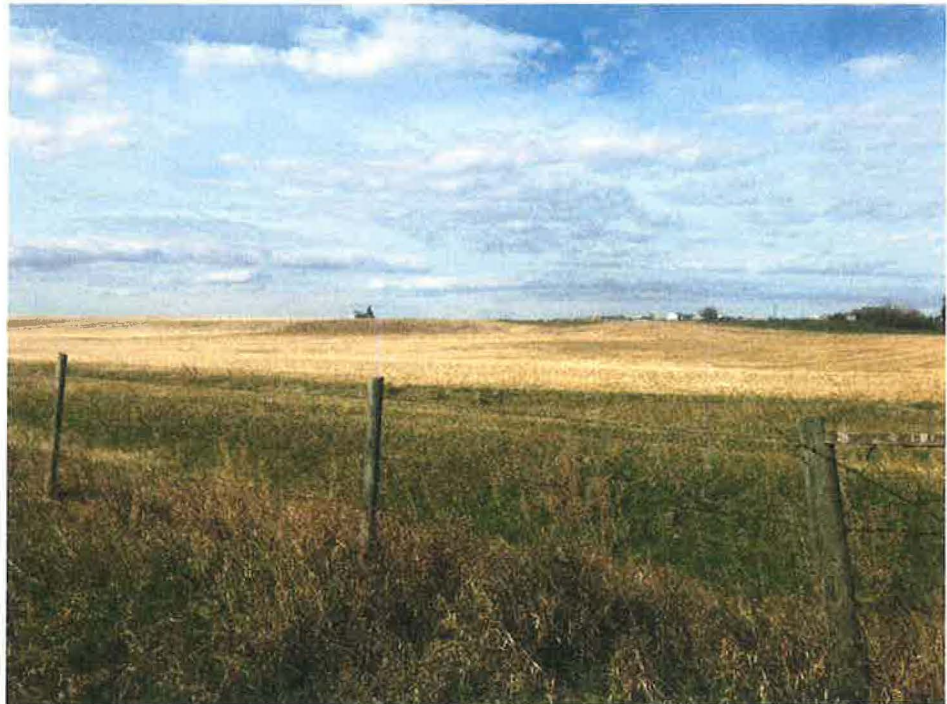
Photo 6: Looking east from the northwest corner of the Site across at the Site. Shows the topography drop where the coulee/creek exits the Site and the 4-acre residential development (not part of the Site) in the background.

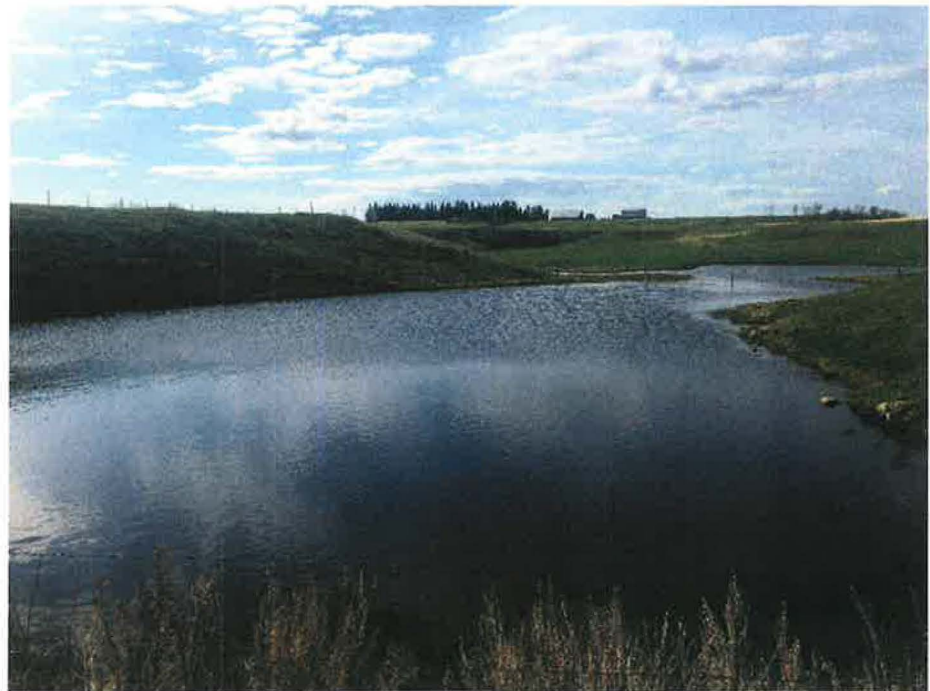
Photo 7: Looking south on the Site from the east-west dirt road the cuts through the coulee. The topographic low point of the Site. Water is flowing in from the south and moving north. There is no sheen on the water or excessive algal build up associated with eutrophication.

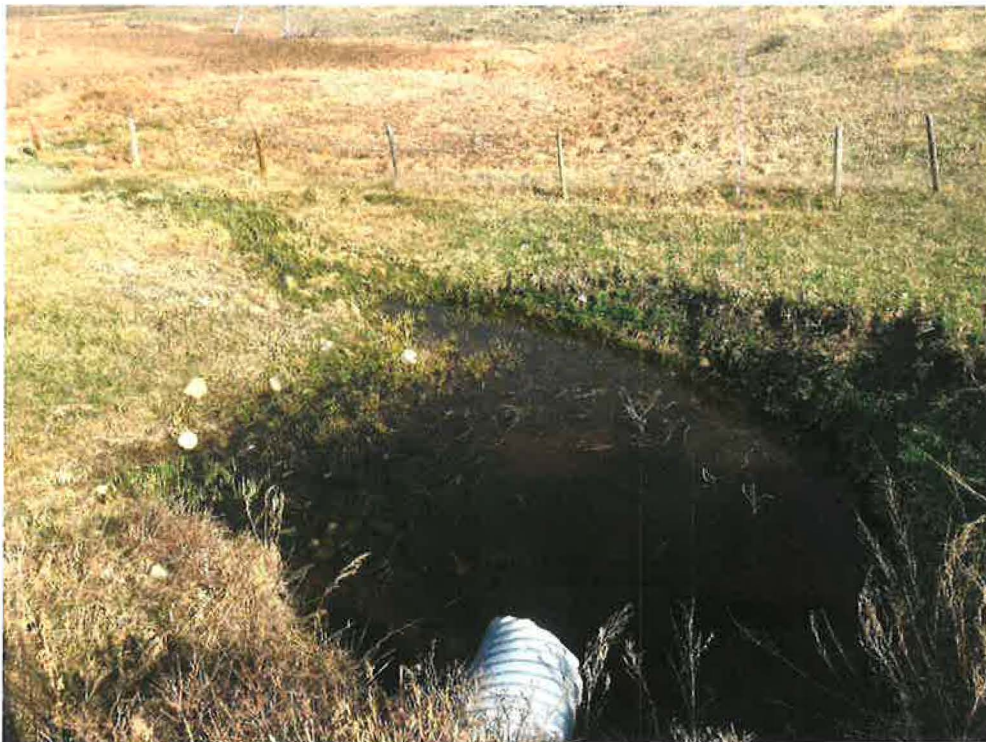
Photo 8: Looking north from the east-west road crossing the coulee at the water continuing to flow towards the north through a culvert installed under the roadway. No sheen or odours were present on the water or adjacent vegetation.

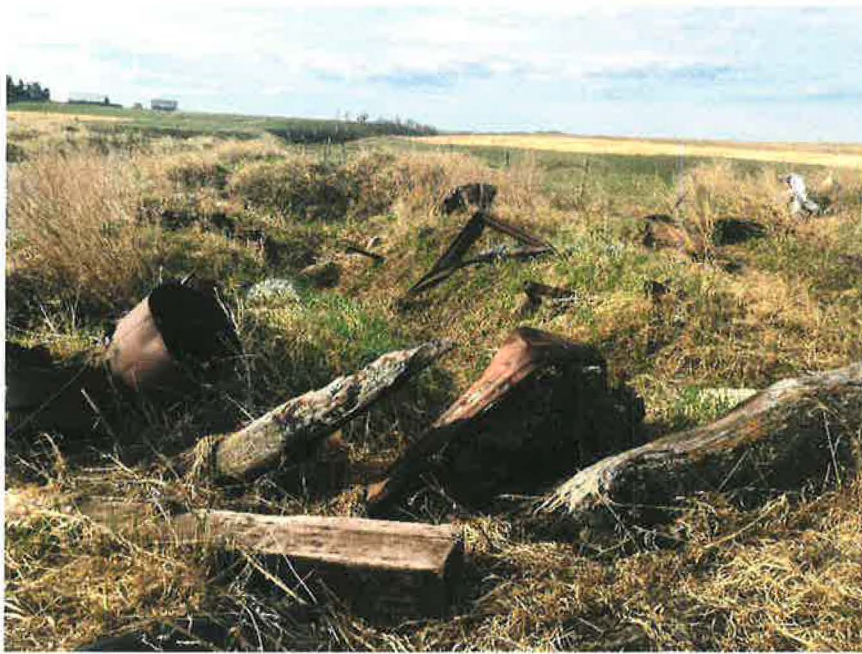
Photo 9: Just east of the coulee there is a collection of materials with burn marks, indicating a possible historical burn pit location within a depression.

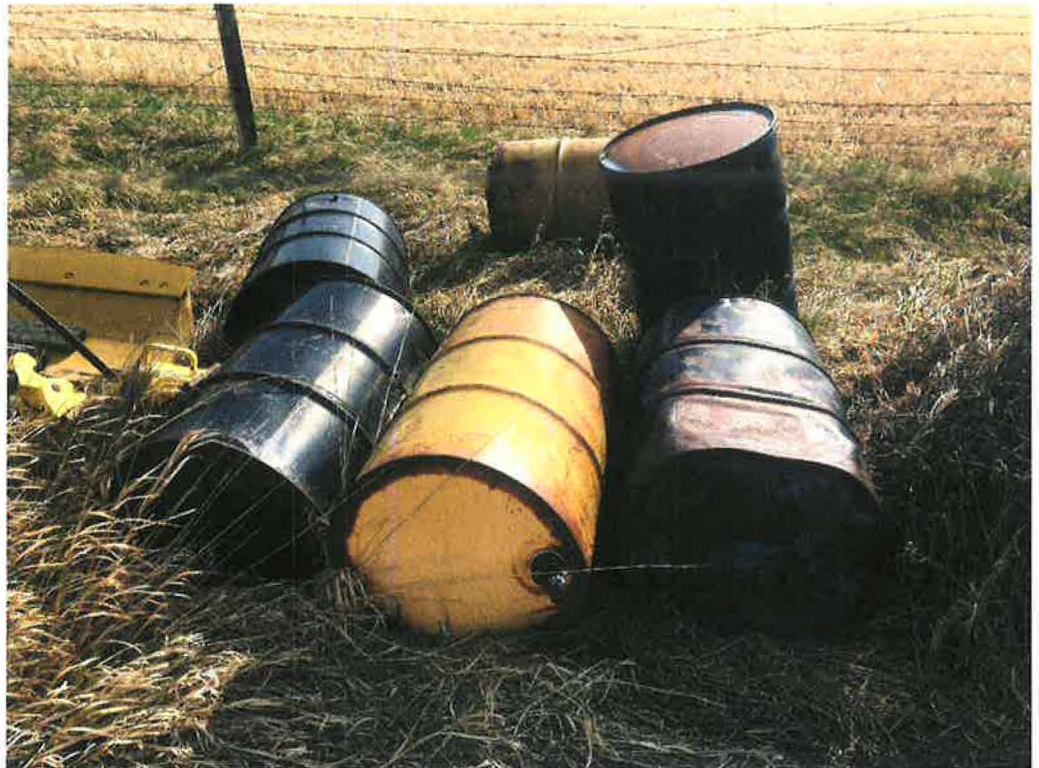
Photo 10: Near photo 9 there were empty metal drums. No staining on the ground around the barrel was found during the Site investigation. Barrels were unlabeled.

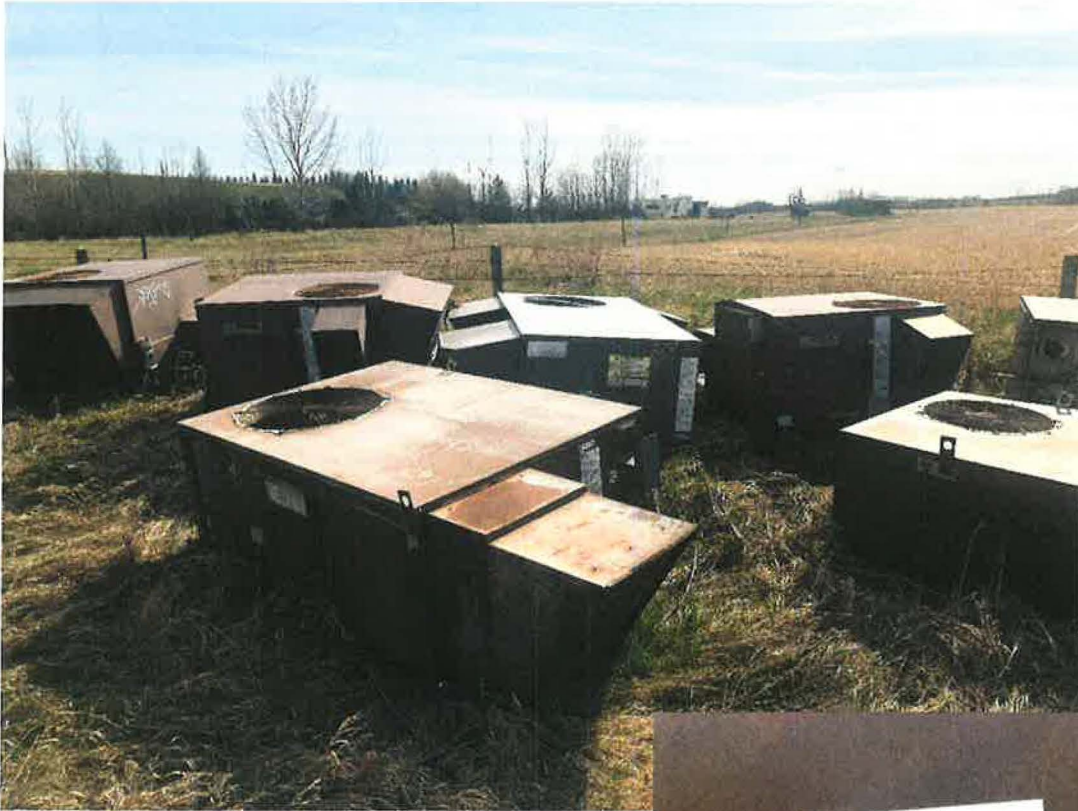
Photo 11: Collection of old heating and heating/cooling units. No staining or associated liquids were found around the units.

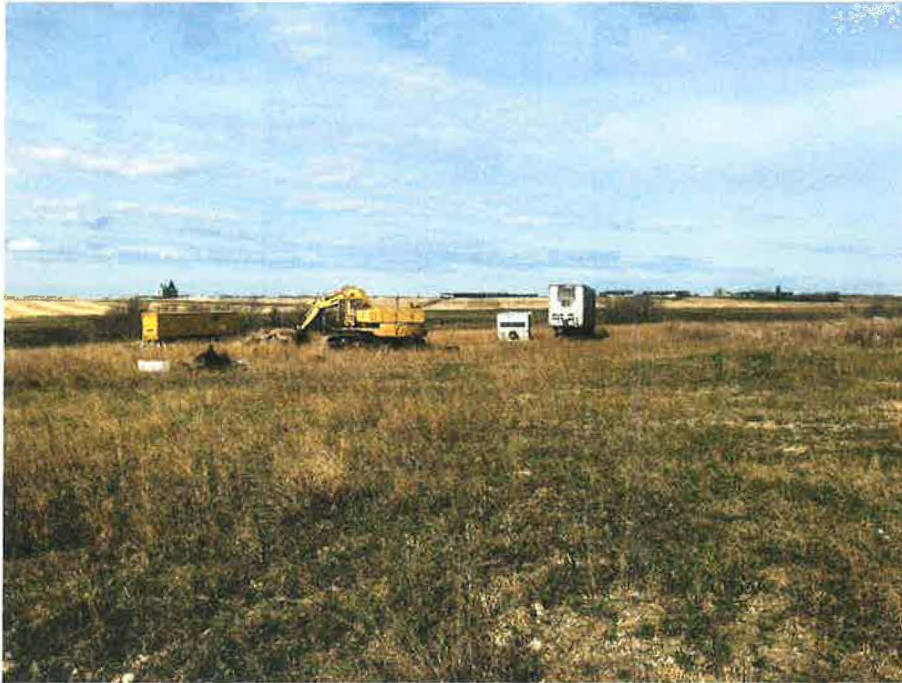
Photo 13: Looking southwest from the northern former gravel extraction site. Showing the excavator, trailer, and RV unit.

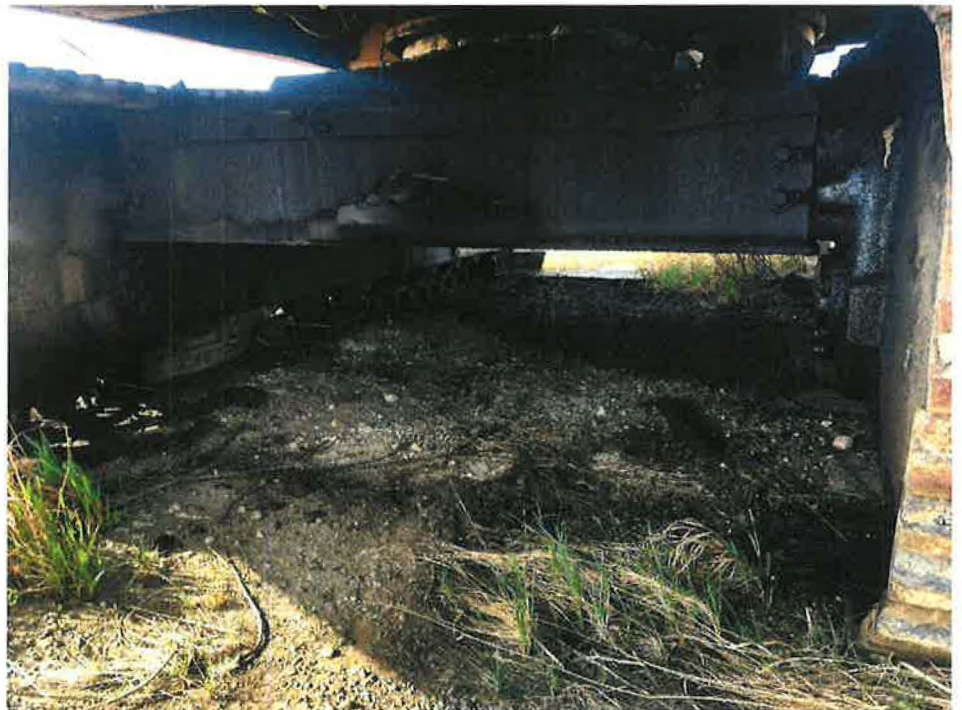
Photo 14: Ground surface under the excavator unit is relatively clean with the exception of a small spot to the front shown in Photo 15 below.

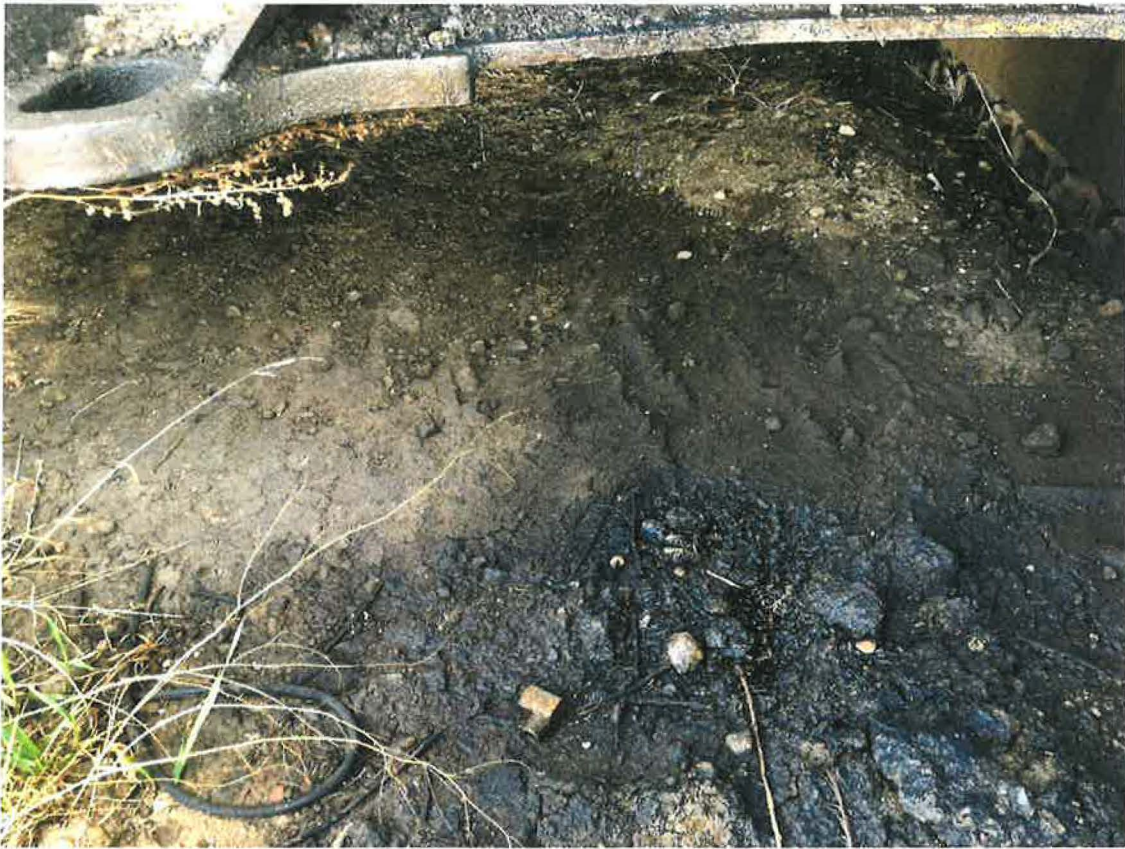
Underneath the excavator present near the northern gravel extraction site there was evidence of lubricant or grease under the front of the excavator, identified by a sheen. The area of impact was less than half a square metre, with a photo included in Appendix B. No other physical indications (spills, odour) of contamination were noted during the Site visit.

Photo 15: Below the front of the excavator there is a small area where grease/lubricant has leaked down to the ground from the excavator.

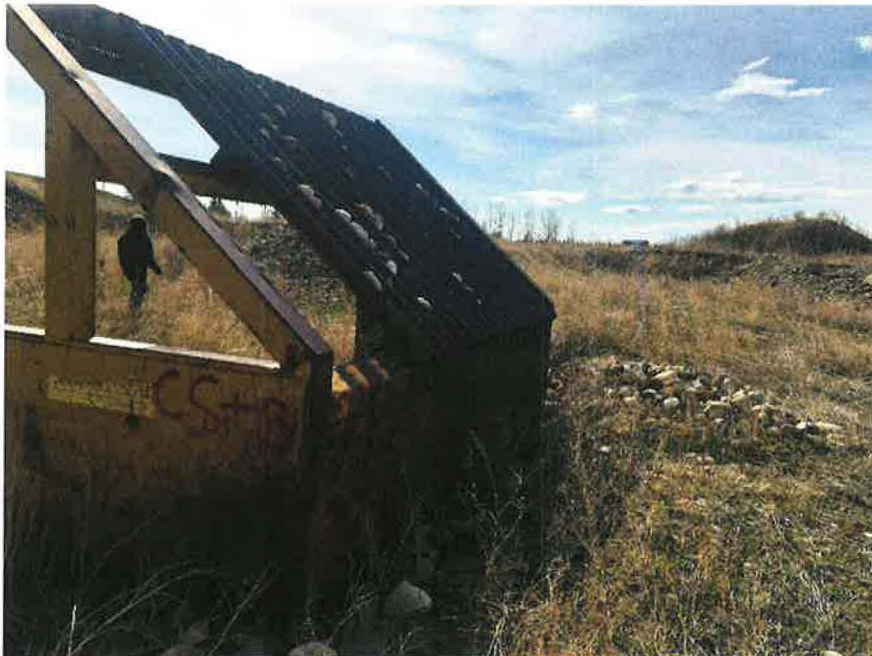
Photo 16: Gravel screen sorter present within the northern former gravel extraction area

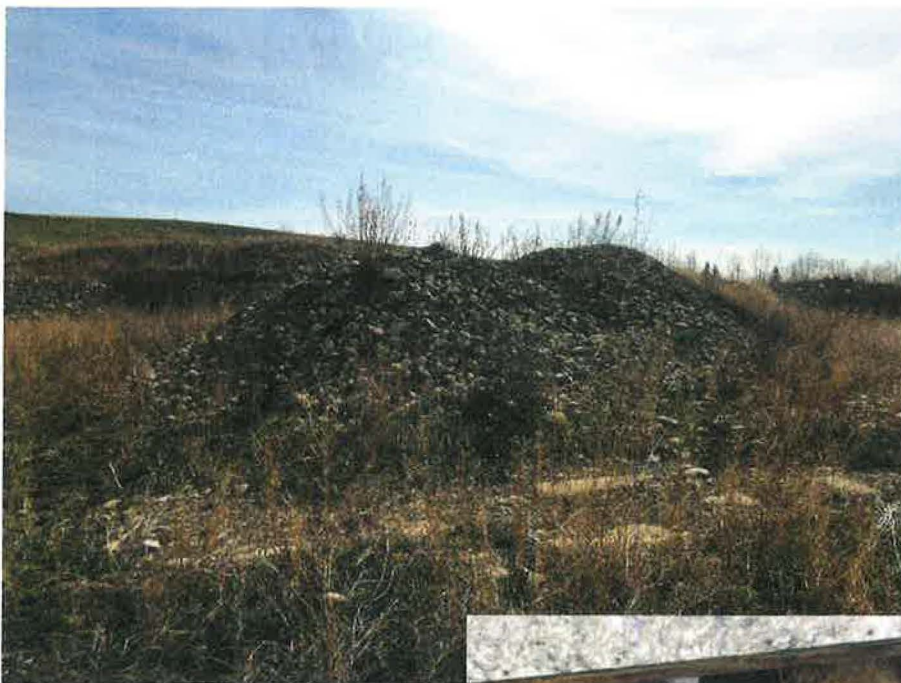
Photo 17: Piles of rock from the former gravel operation with vegetative growth

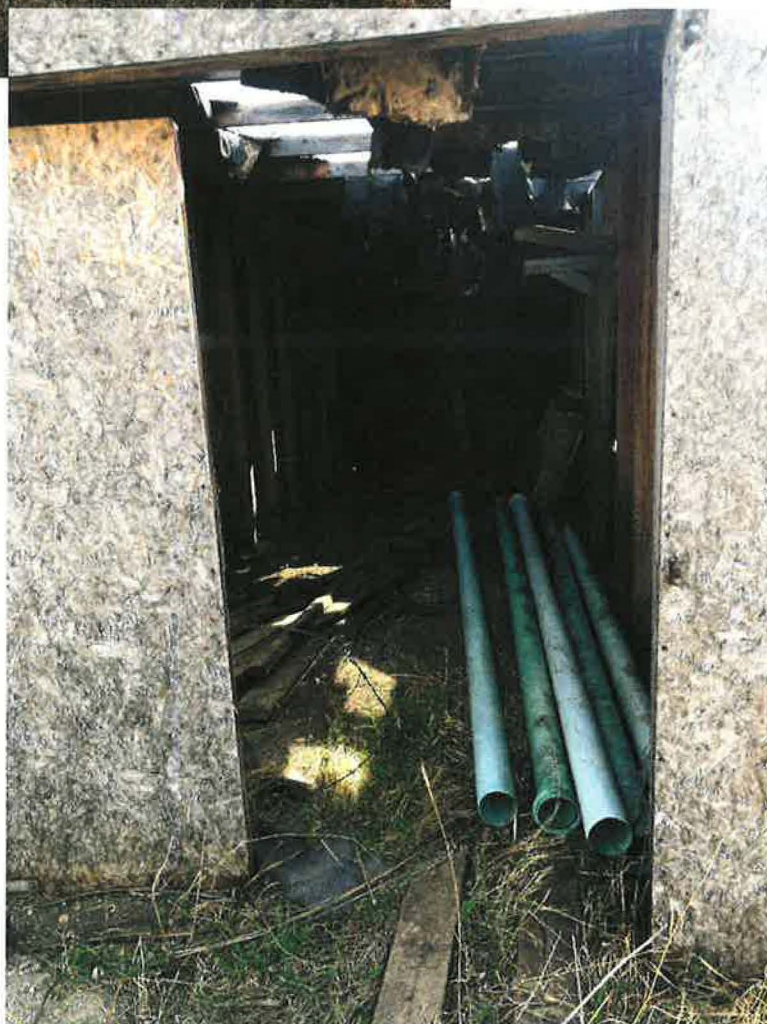
Photo 18: Material storage shed near the former gravel extraction site in the north of the Site. Plywood construction. No chemical or liquid storage present.

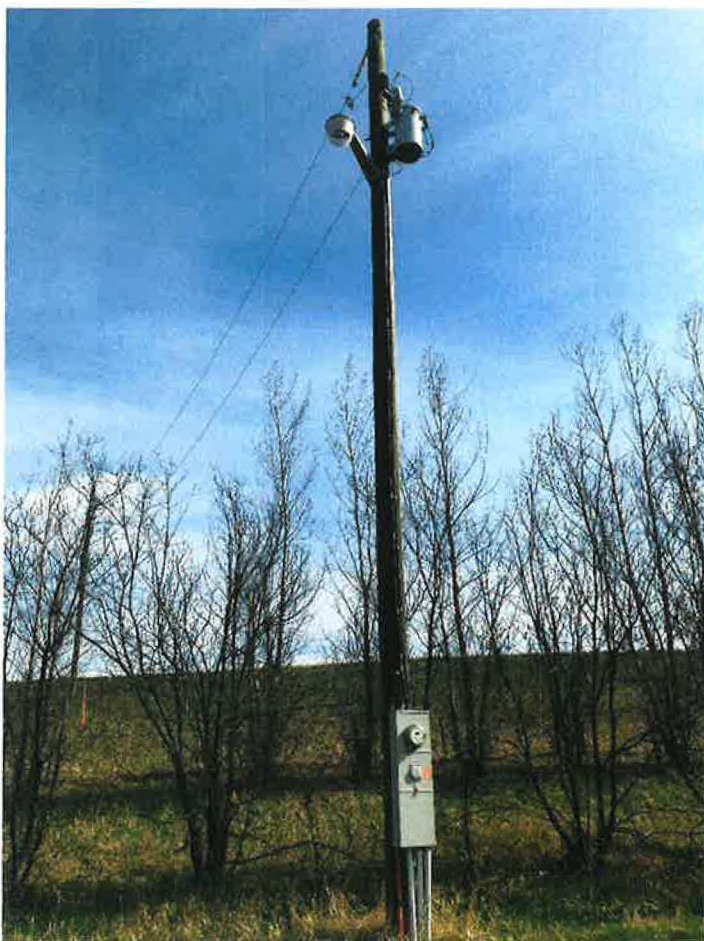
One pole mounted transformer (PMT) was observed north from the residential farmstead garage. The PMT appeared relatively new and in good condition with no apparent leaks observed.

Photo 19: Power pole with transformer present south of the garage near the residential home on Site.

Electrical equipment taken out of service should be checked prior to disposal and any found or suspected to contain PCBs should be handled and stored as required by Section 12 of the Alberta Environmental Protection and Enhancement Act's Waste Control Regulation.

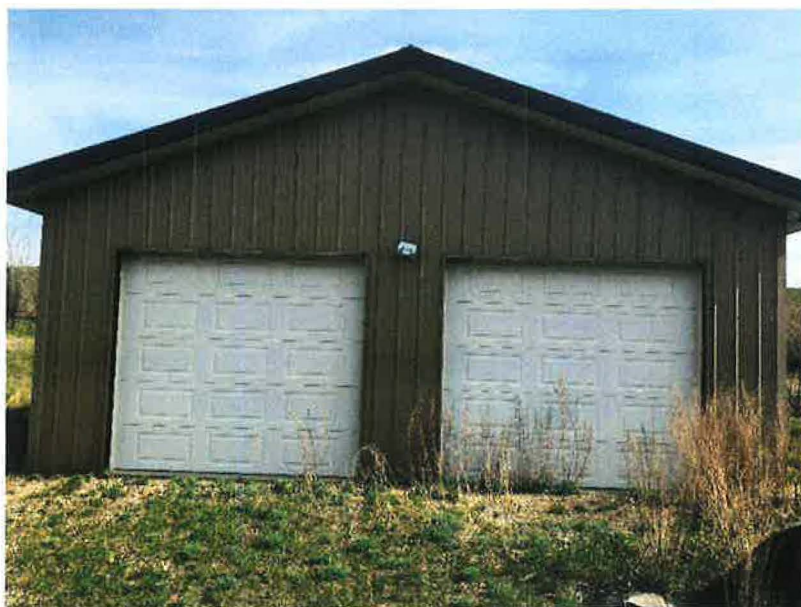
Photo 20: Double garage building present to the east of the mobile home showing building age and construction

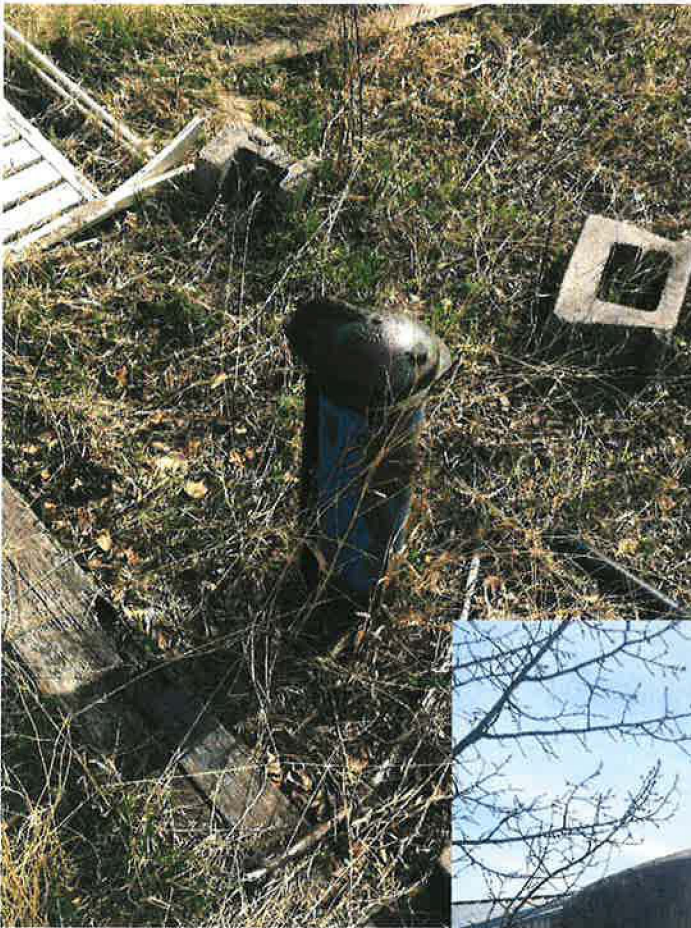
Photo 21: Water supply well located to the east of the mobile home and garages. Wires to connect a pump were still present in the well

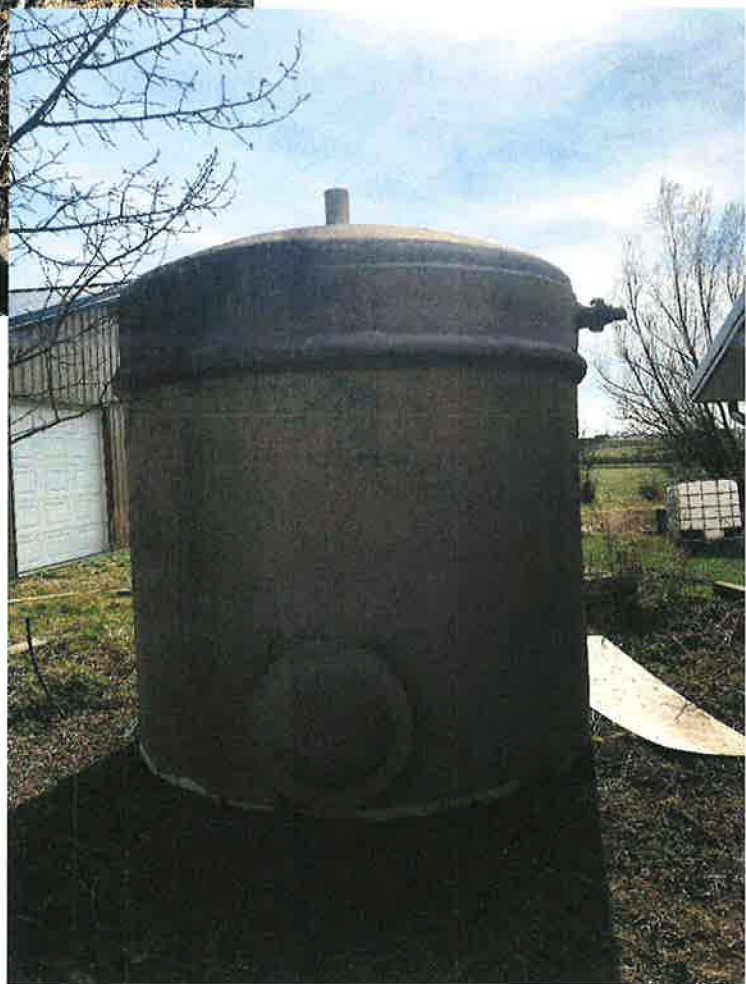
Photo 22: Water storage tank behind the double door garage. No leaks or staining around the tank was present.

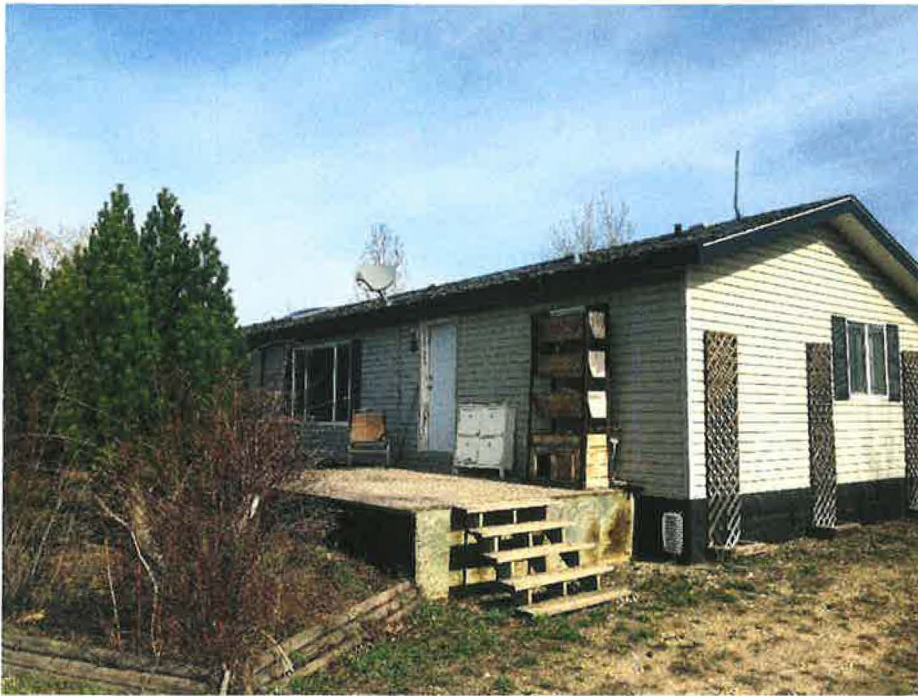
Photo 23: Mobile home present within the east of the Site

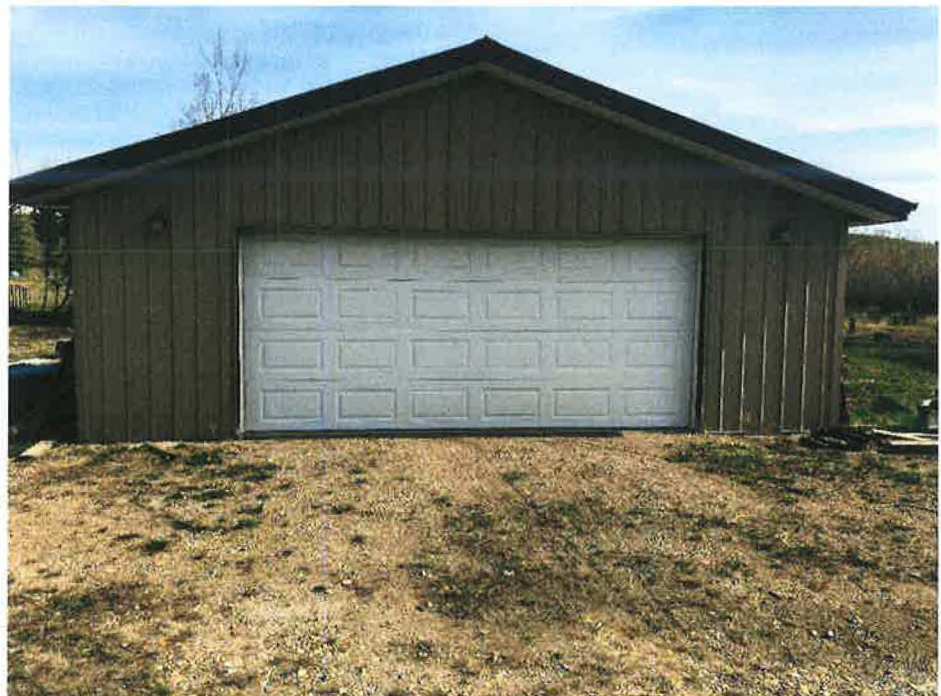
Photo 24: Single door garage/shed located east of the mobile home

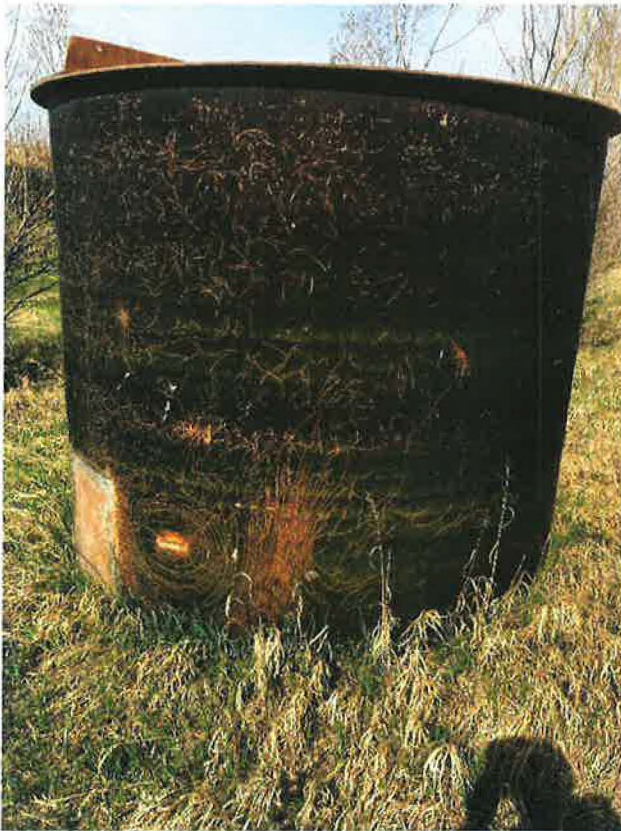
Photo 25: Fibre glass above ground storage tank located south of the garage buildings. No leaks, stains or stressed vegetation were noted around the tank during the Site visit.

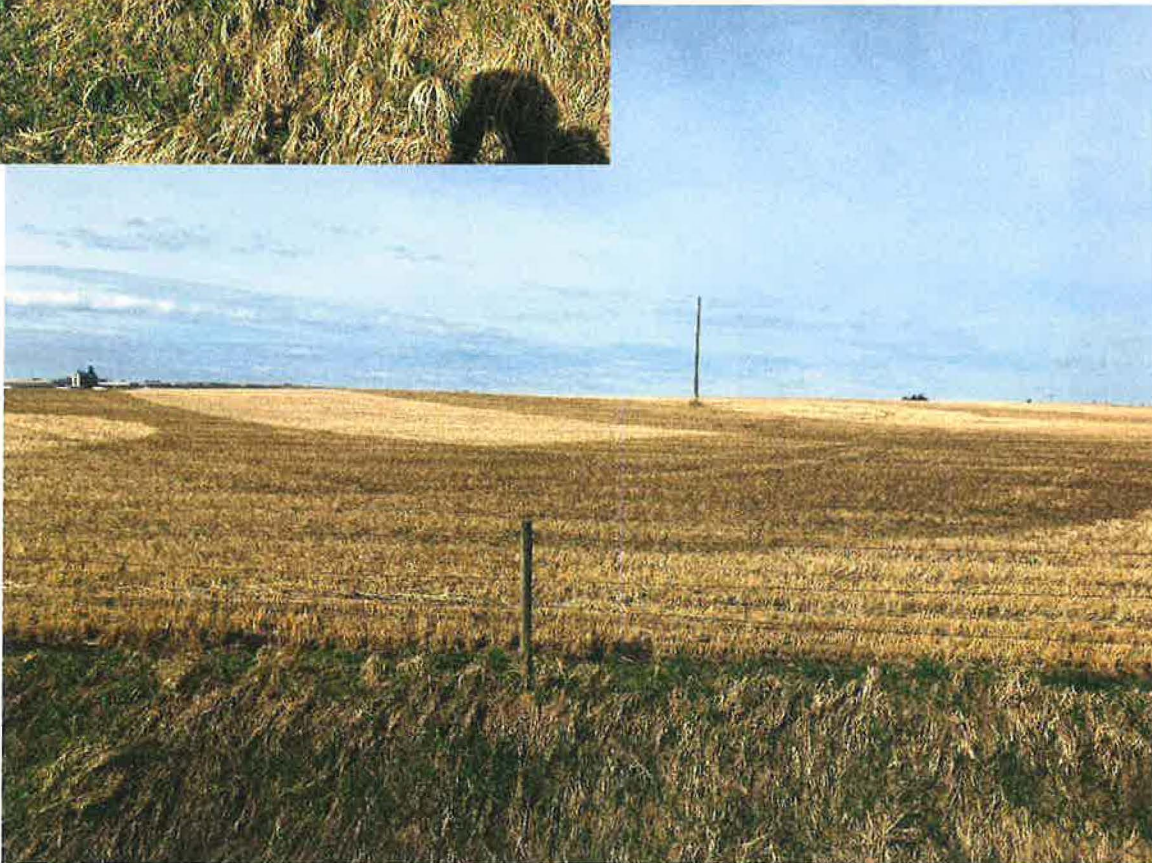
Photo 26: Looking west across the Site from the northeast corner at the above ground power line running across the northeast of the Site down towards the mobile home.
