# APPENDIX P

**Environmental and Remediation Services Inc.**

### Photograph Log

RE: Geophyical Surveys at 07-03-033-01 W5 and 08-03-033-01 W5, OLDS, ALBERTA

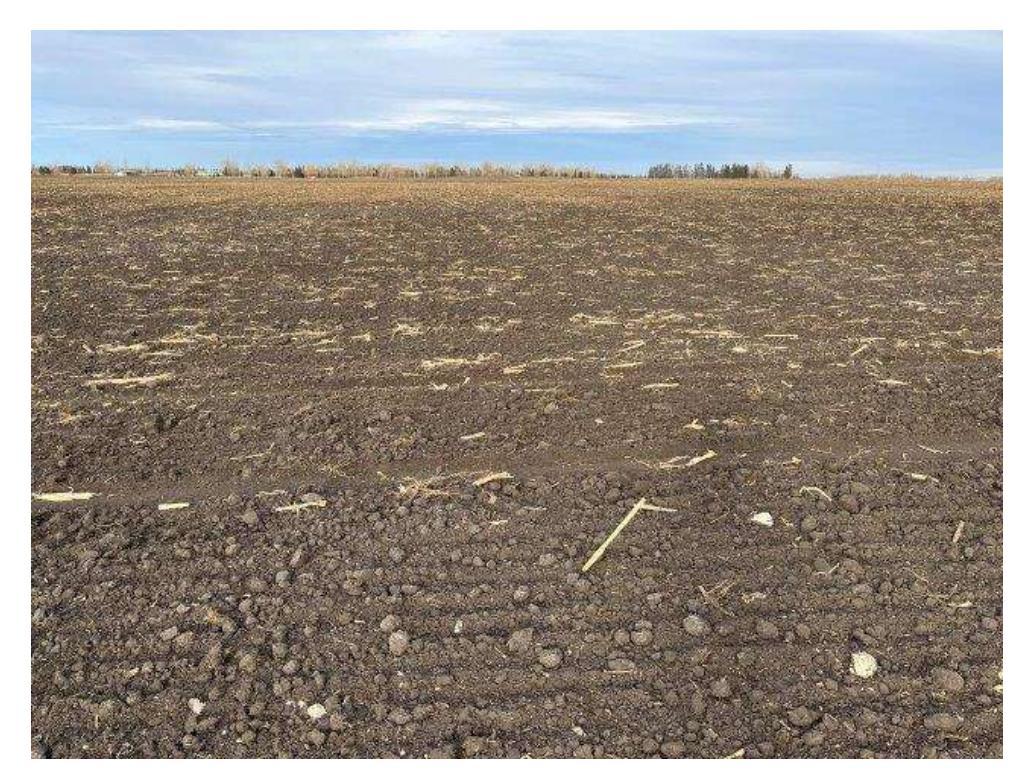
1. The Project Site and a representative view from the southern side of the property along Highway 27, facing north.

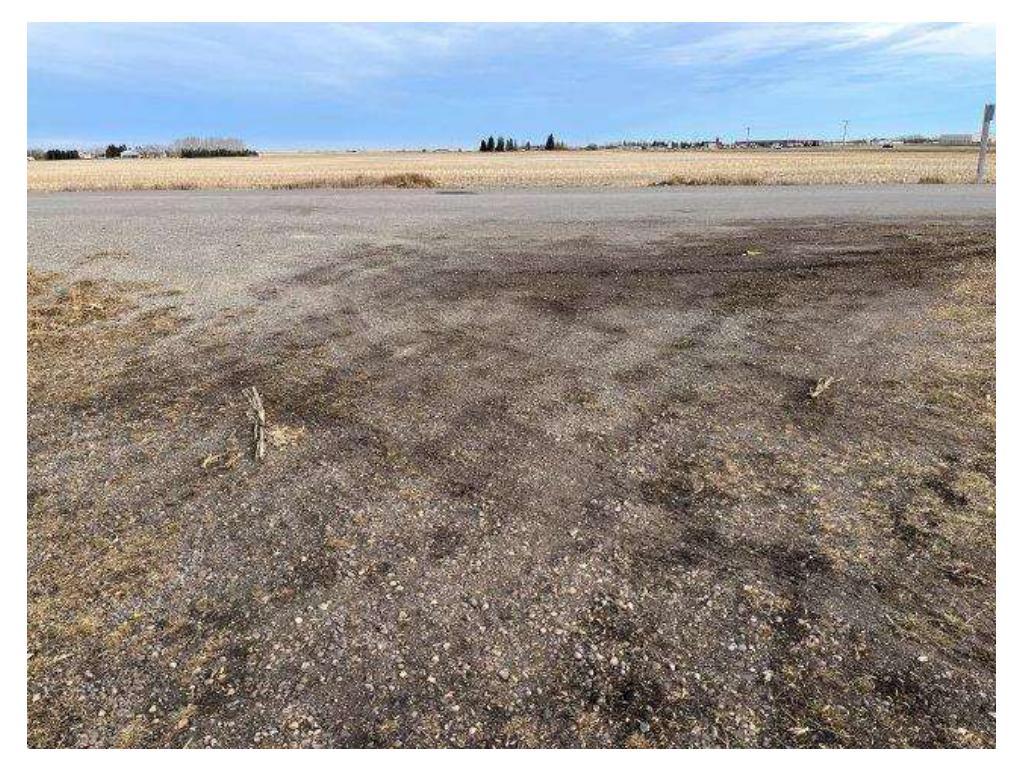
2. View to the east along Range Road 12 of the southeastern Project Site access point, from within the property.

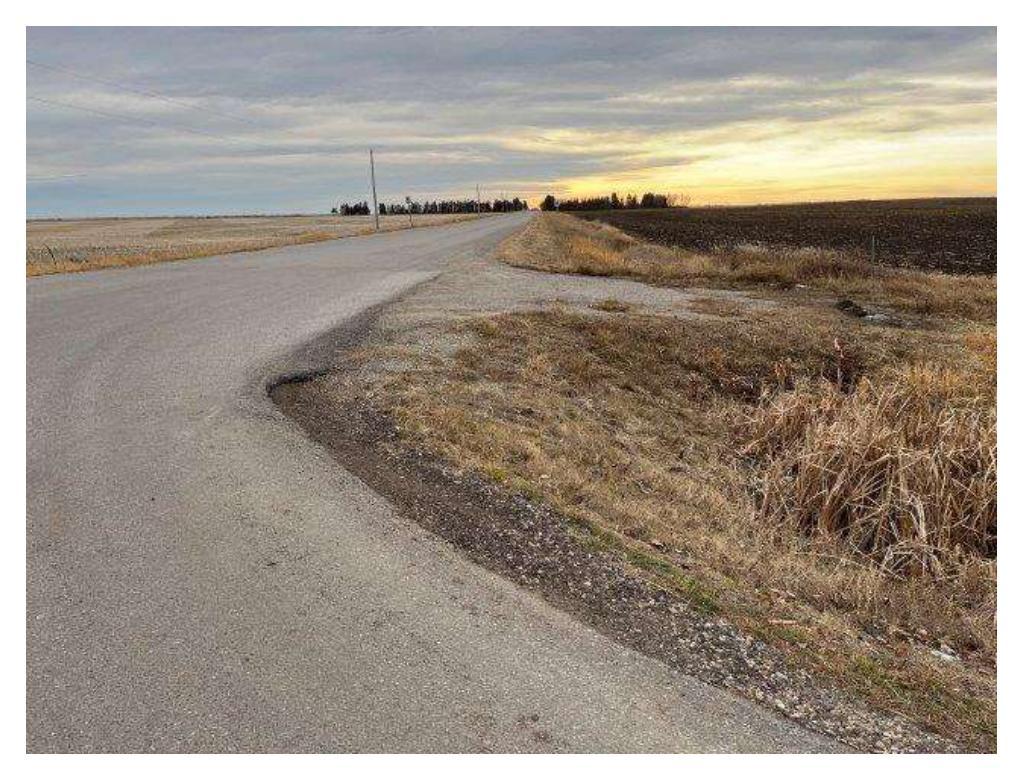
3. View to the south along Range Road 12 of the northeastern Project Site access point.

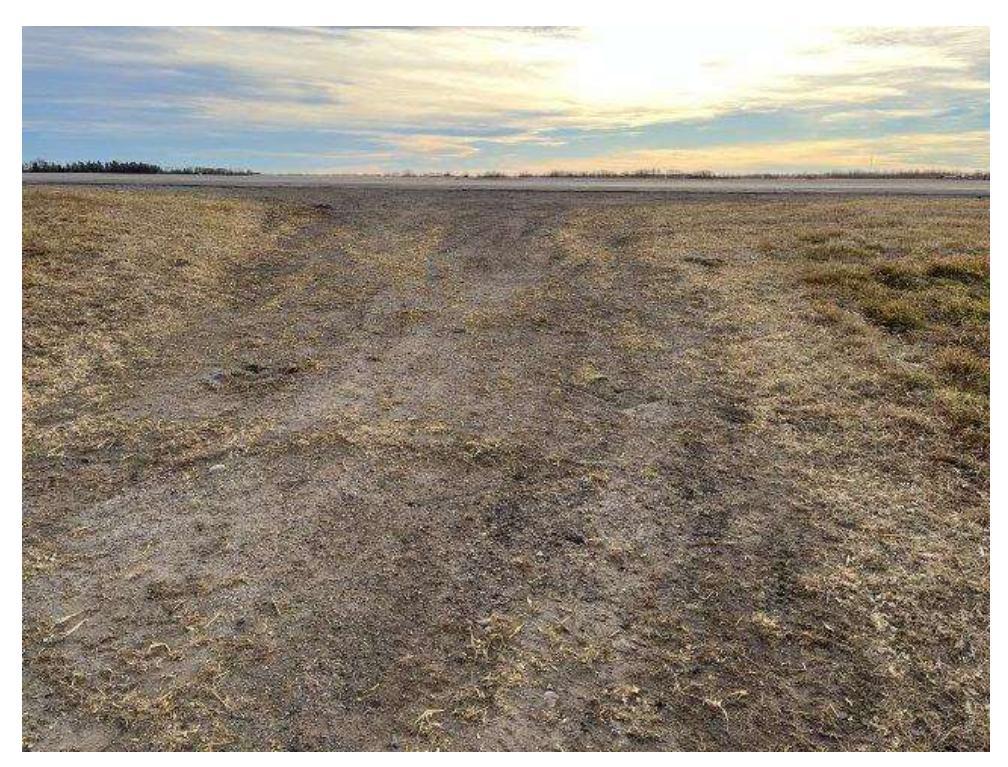
4. View to the south along Highway 27 of the southwestern Project Site access point, from within the property.

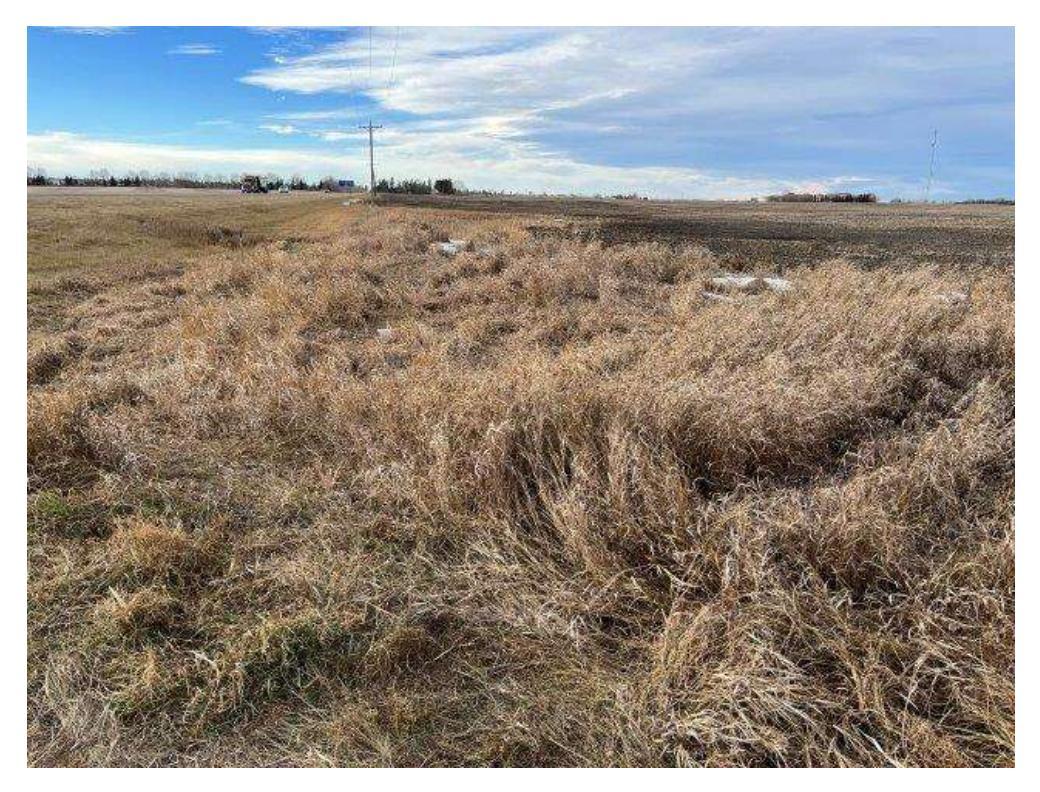
5. View from the grasses and other vegetation within the southern Project Site ditch.

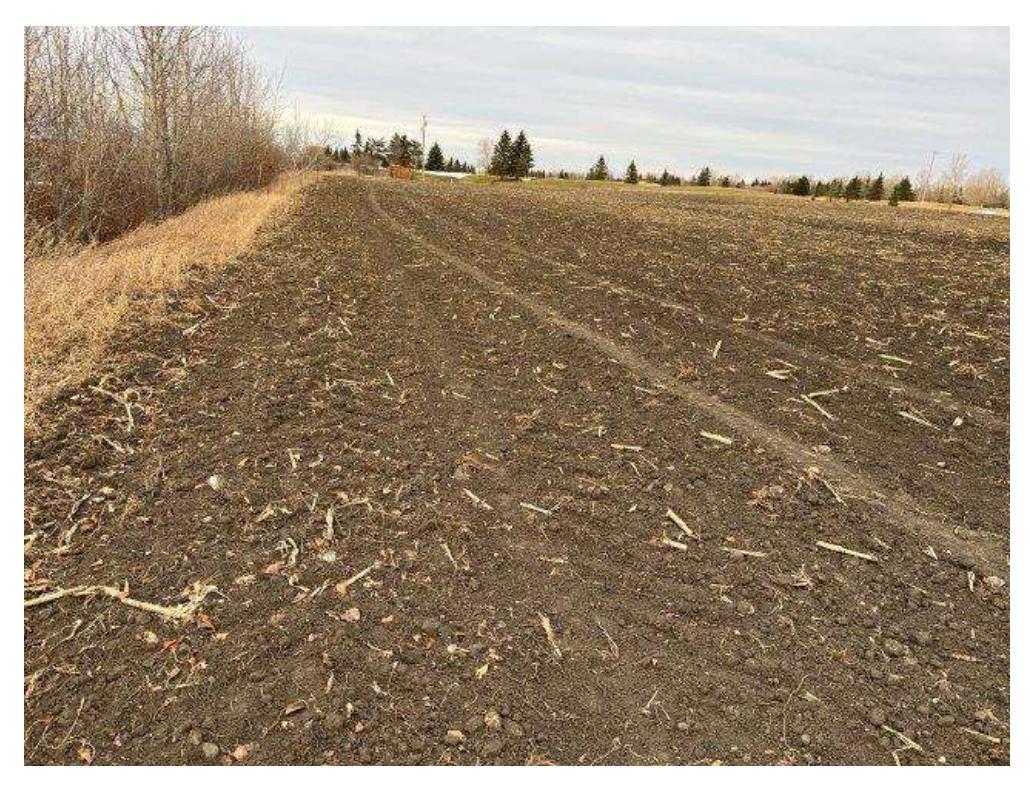
6. View of the ditch (upper right of the photograph) along the western property boundary, facing north, that contains small trees.

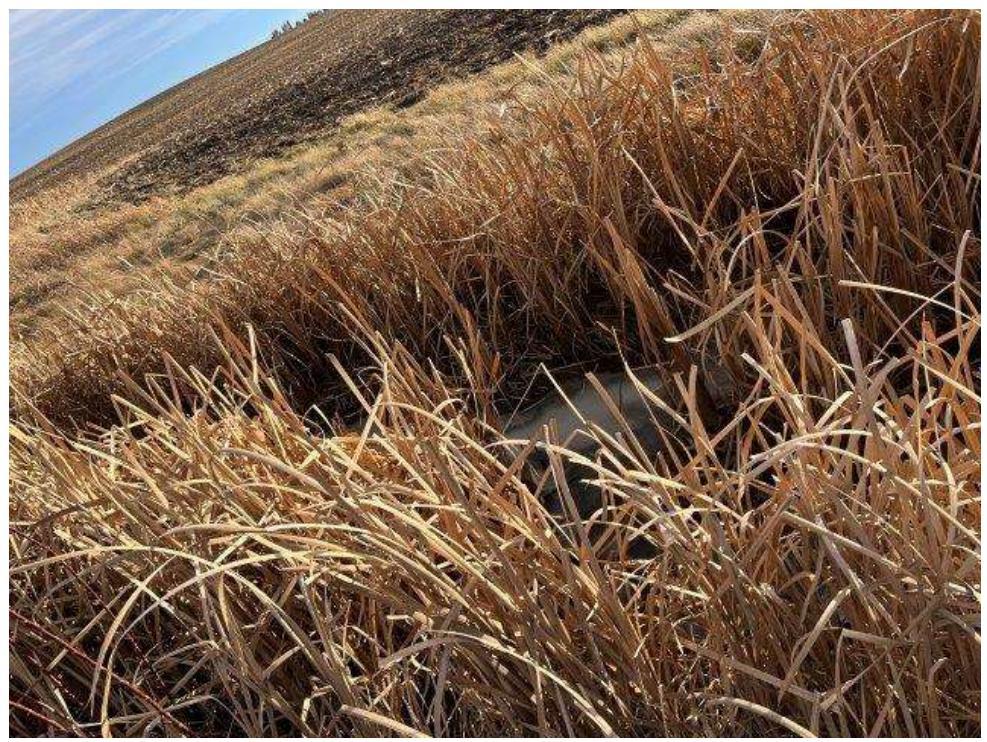
7. The ditch along the northern boundary of the Project Site, which is filled with water and water-tolerant plants, facing south east.

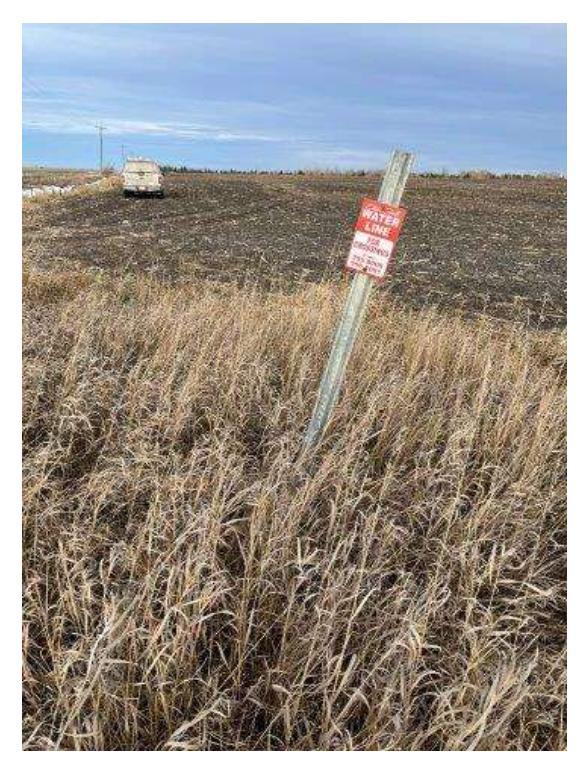
8. View to the north along Highway 27 of the southwestern corner of the Project Site, showing a buried water line sign.

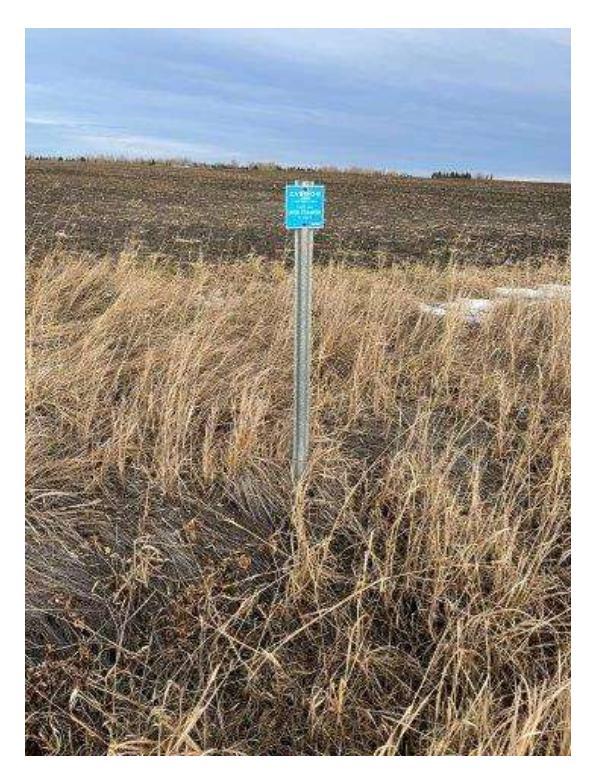
9. View north along Highway 27 of the southwestern corner of the Project Site, showing a buried fiber optic line sign.

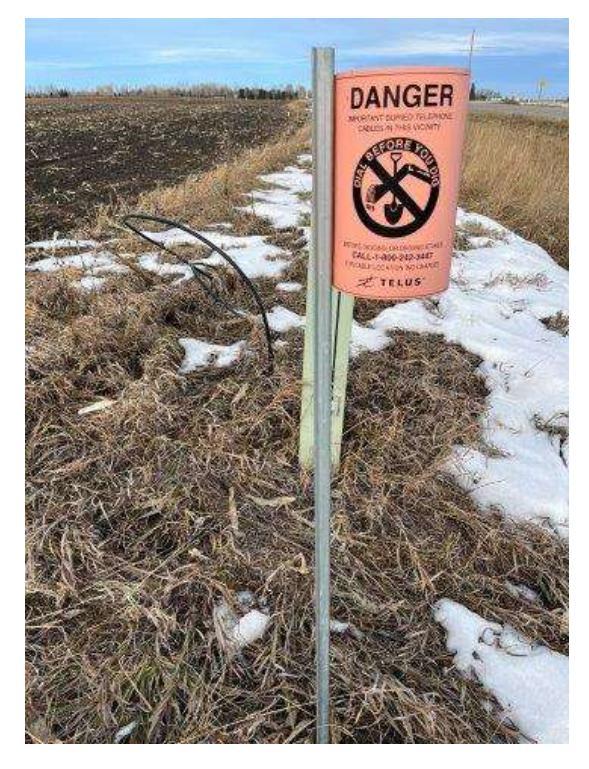
10. View of a buried telephone cable sign along Range Road 12 in the southeastern corner of the Project Site; photograph taken facing north.

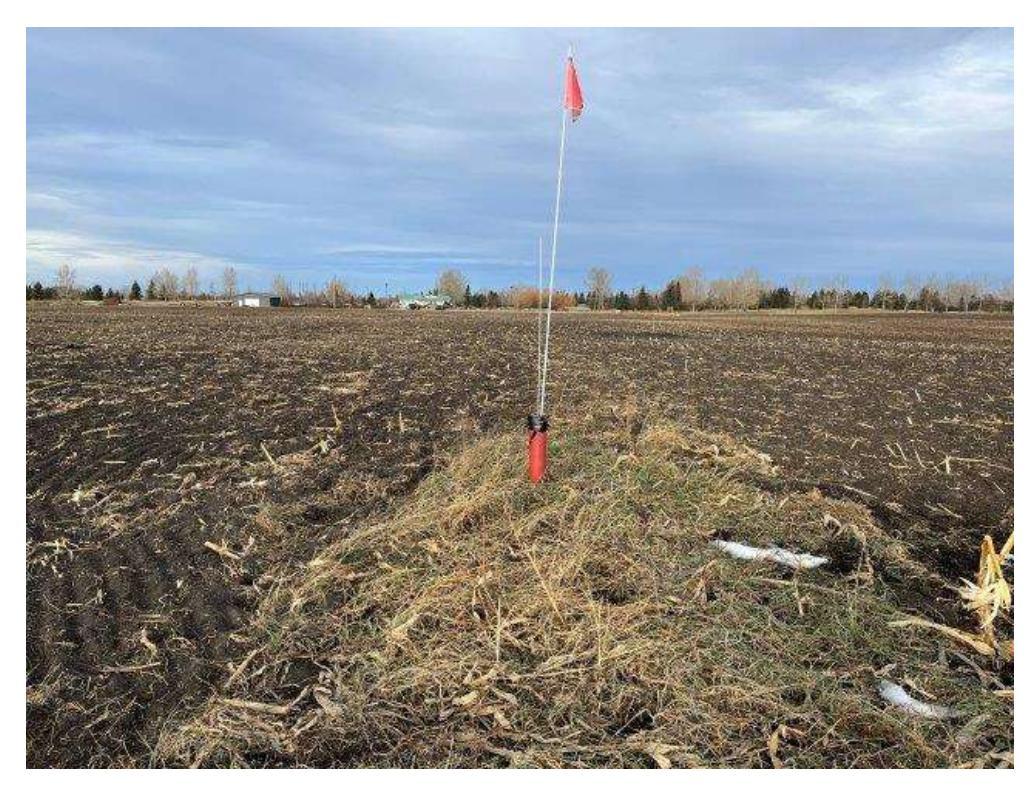
11. View of the monitoring well located in the northcentral portion of the Project Site; photograph taken facing north.

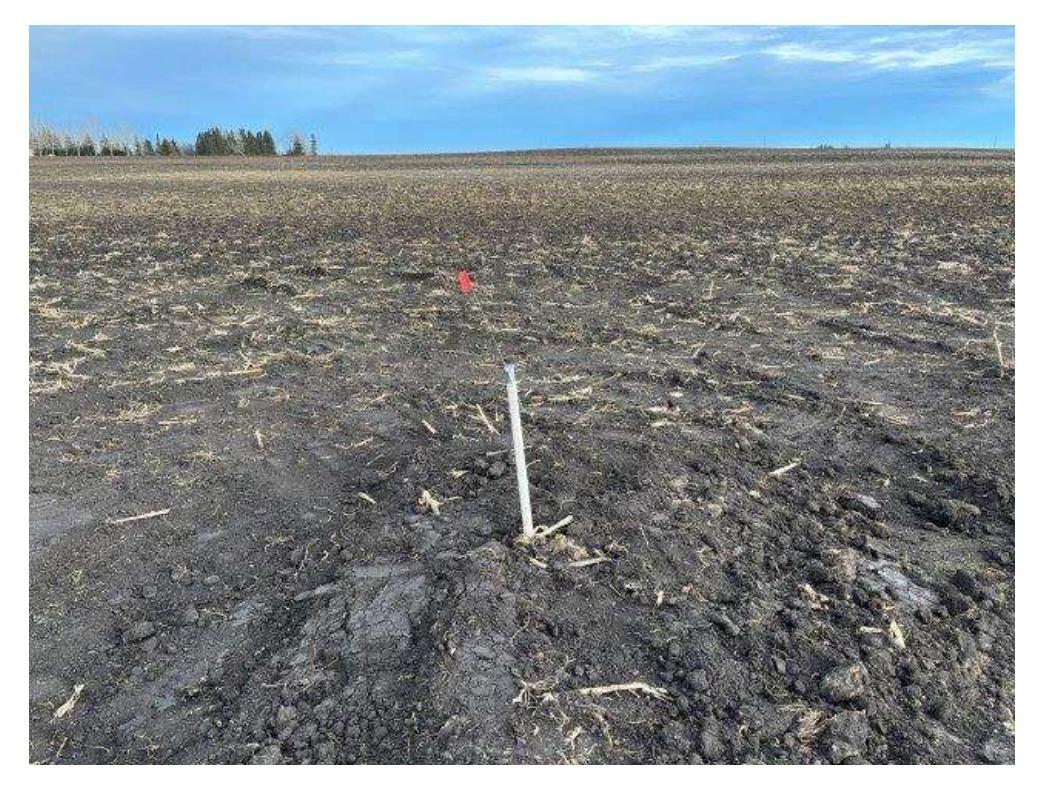
12. View of the geotechnical stand pipe piezometer located in the northcentral portion of the Project Site; photograph taken facing east.

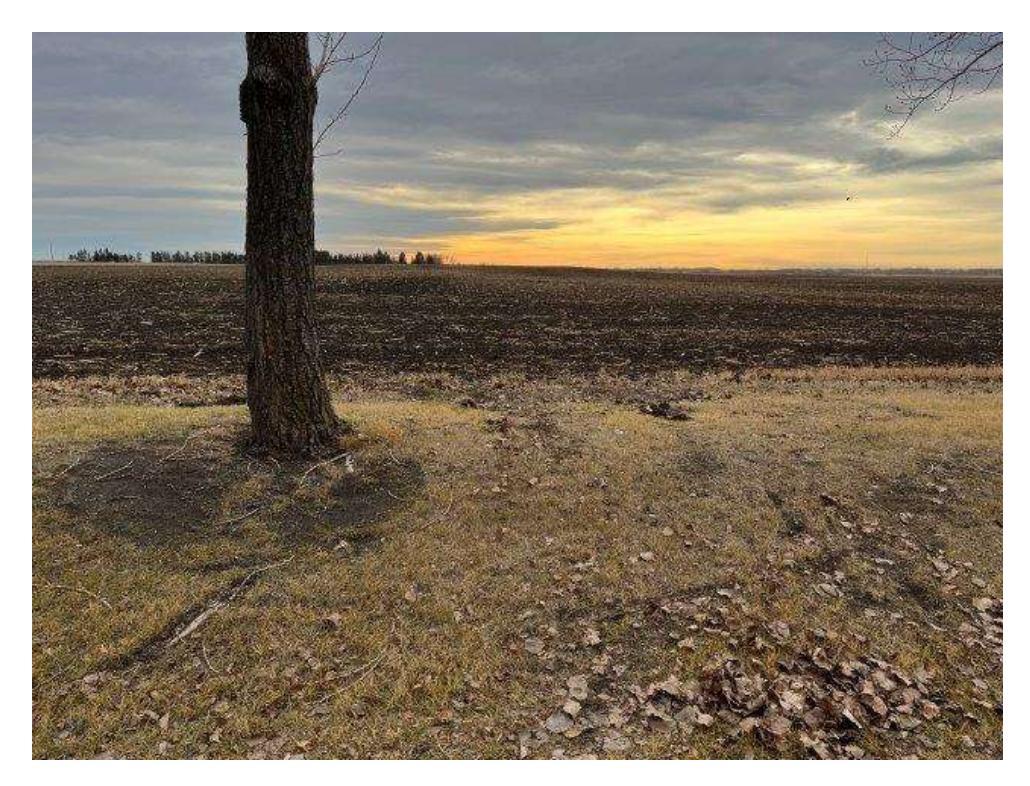
13. View to the south along the northern Project Site boundary. The change in vegetation type past the tree indicates the location of the drainage ditch.

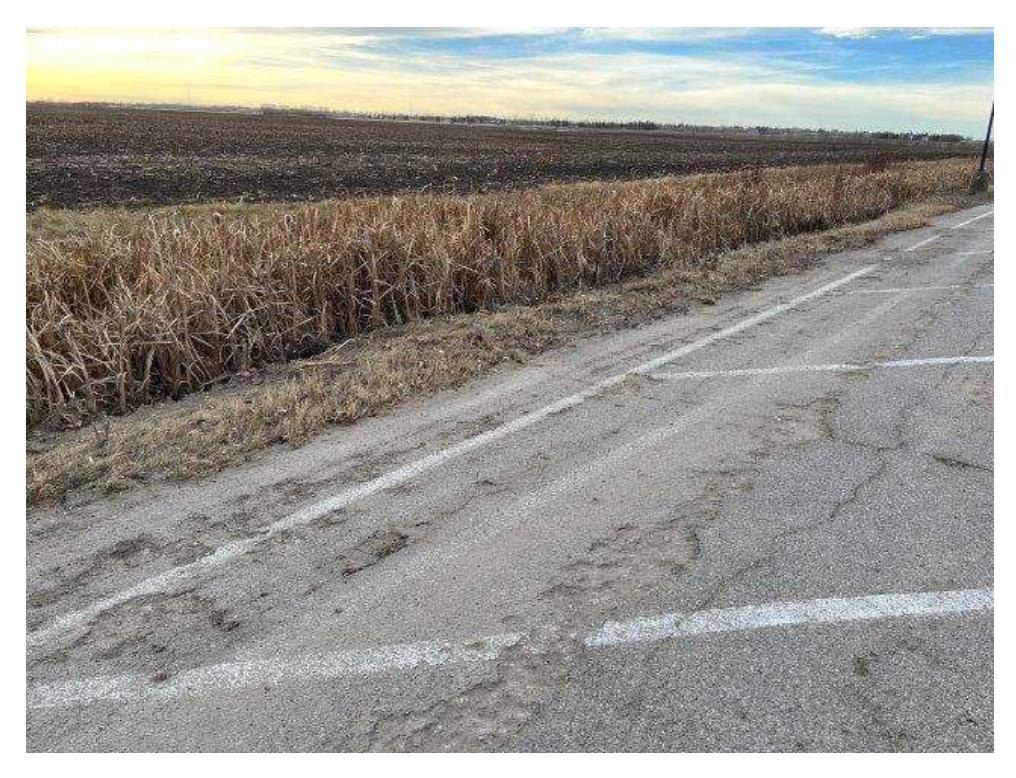
14. View to the south along the northern Project Site boundary. The change in vegetation type is clear and indicates the location of the drainage ditch.

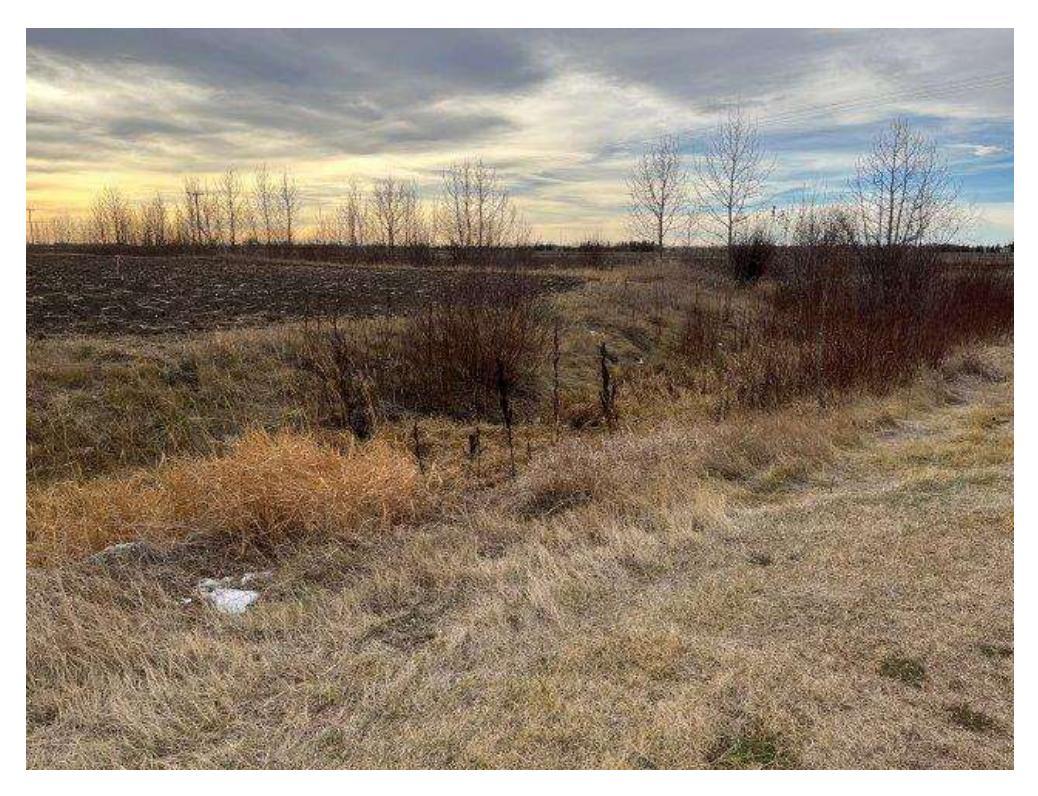
15. View of the northwestern corner of the Project Site and Block A, showing the ditch and tree growth on this corner; photograph taken facing southwest.

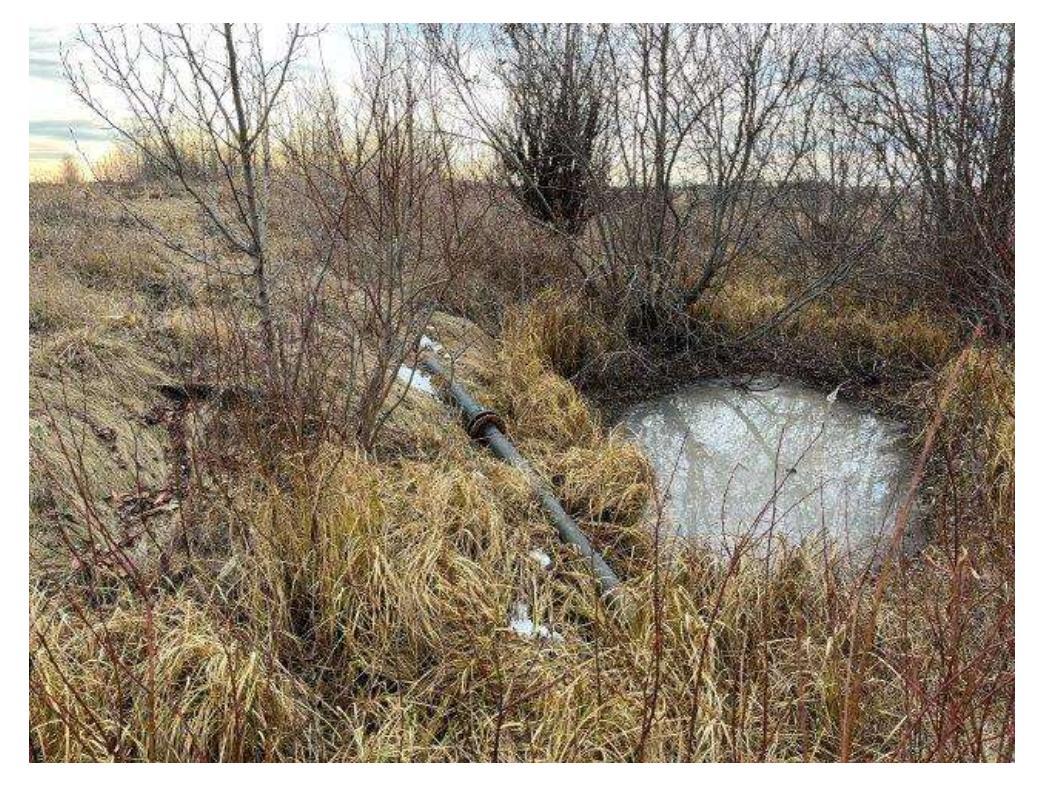
16. View facing south west of the water line that runs from the pump house on Location 2 to the southern property line along the western property boundary.

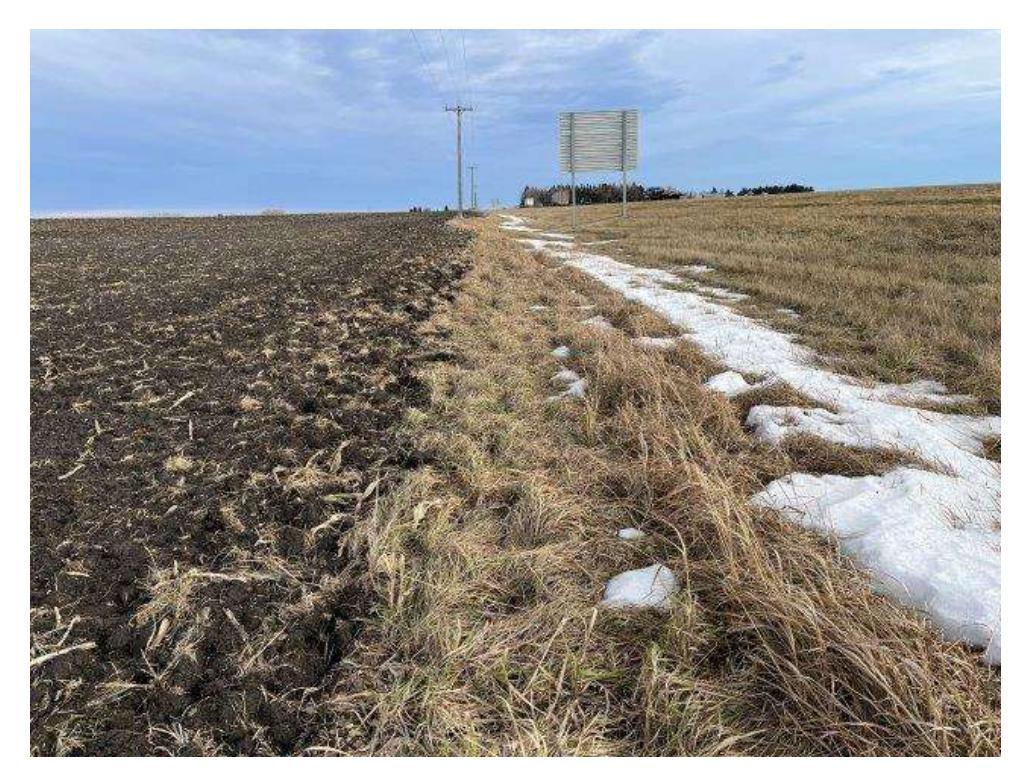
17. View to the power lines along Highway 27 on the southern side of the Project Site access; photograph taken facing east.

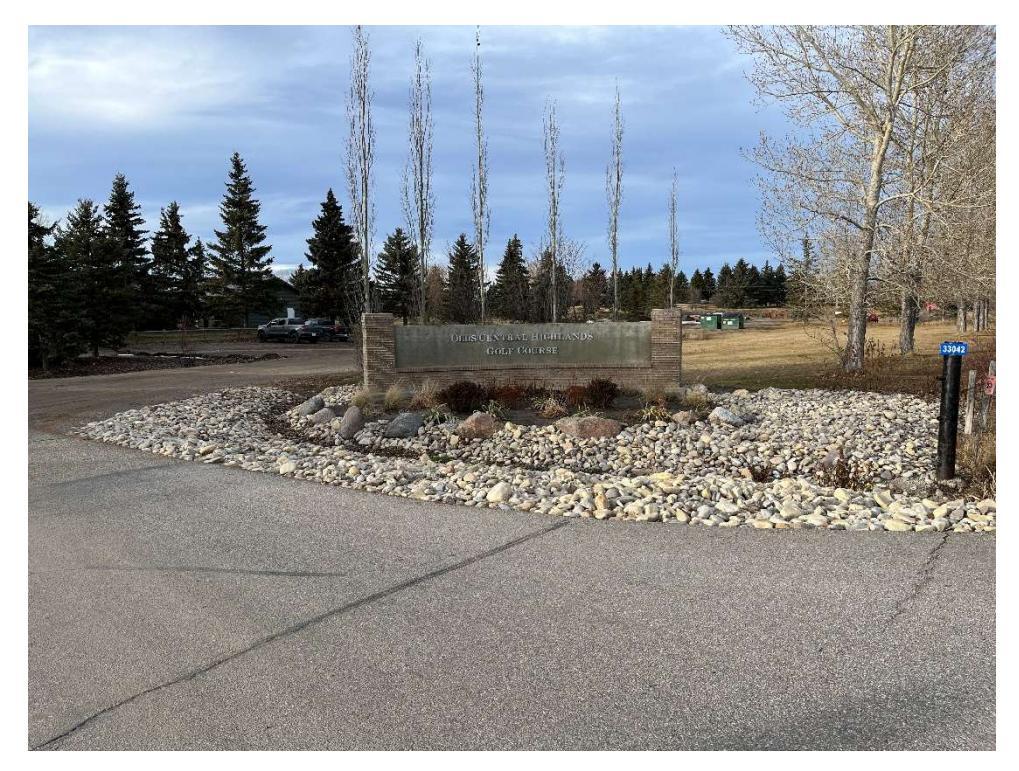
18. View of the main entrance to the Olds Golf Club, west of Range Road 12; photograph taken facing northwest.

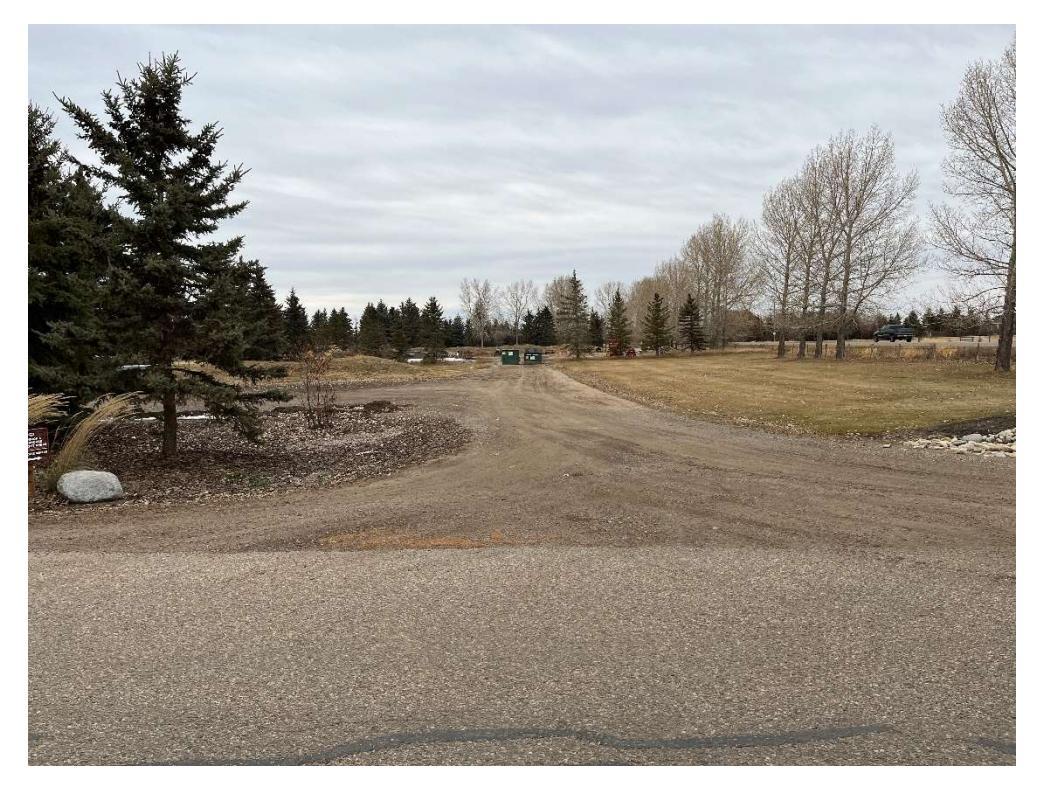
19. A pair of solid waste dumpsters at the Olds Golf Club, near the entrance off of Range Road 12; Photograph taken facing north.

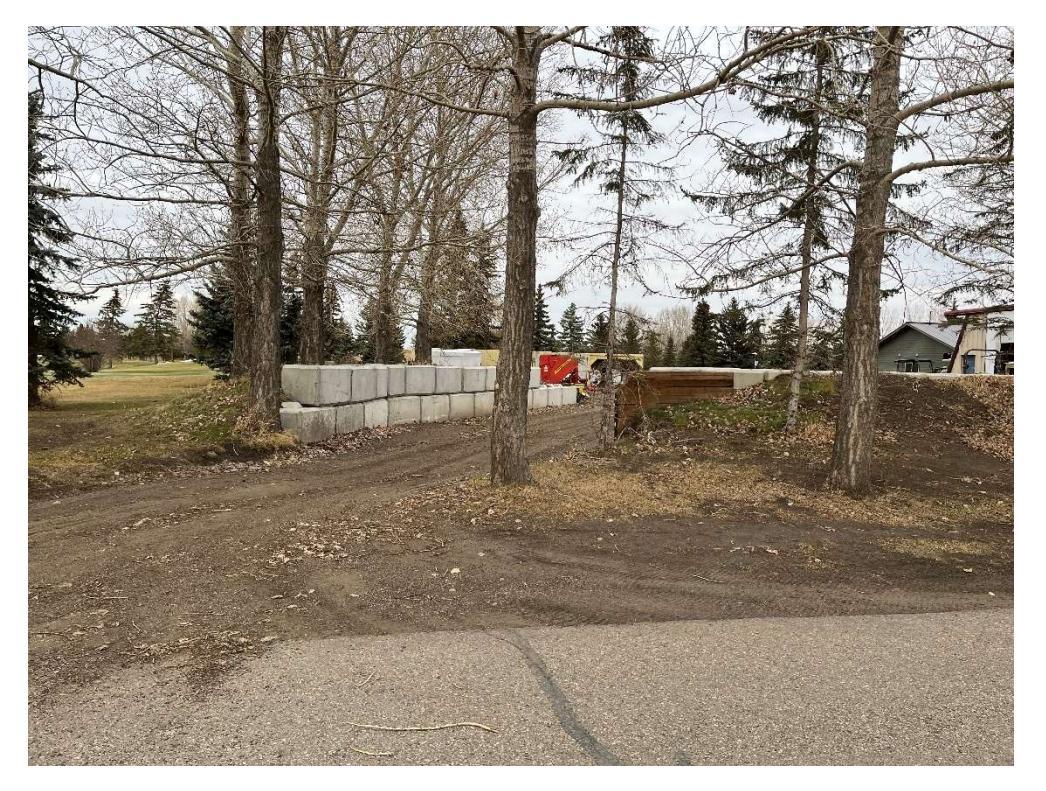
20. Entrance to the maintenance area at the Olds Golf Club; photograph taken facing northwest.

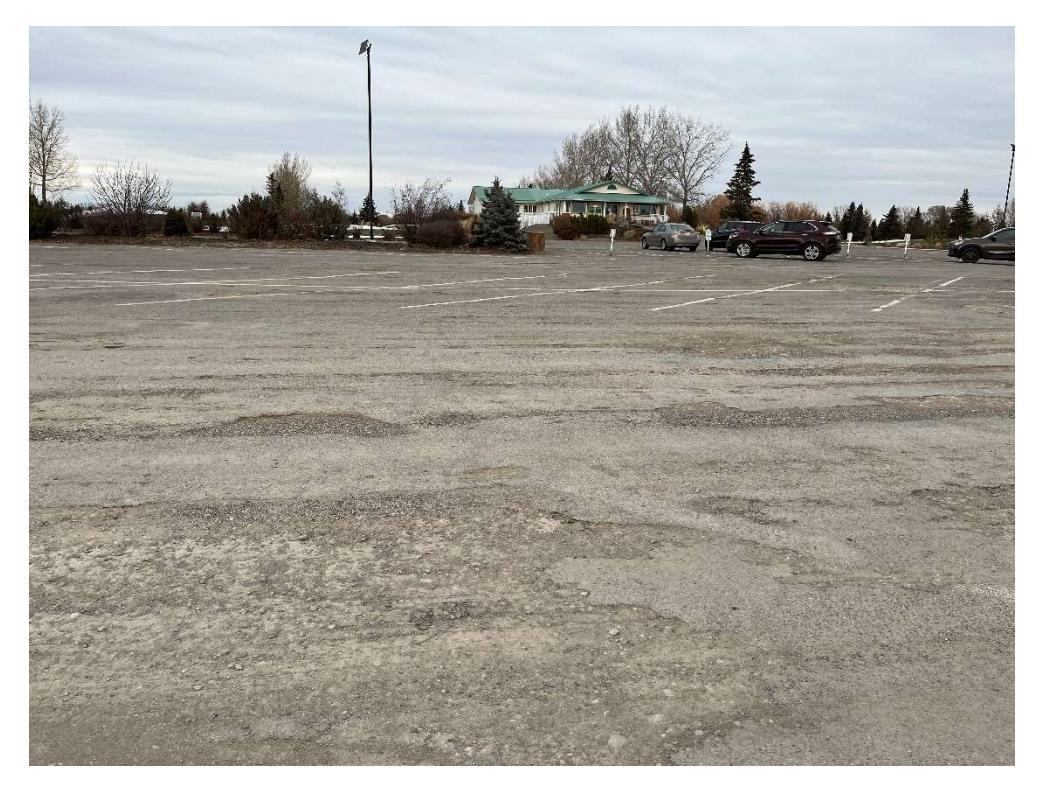
24. View of the clubhouse on the Olds Golf Course; photograph taken facing north.

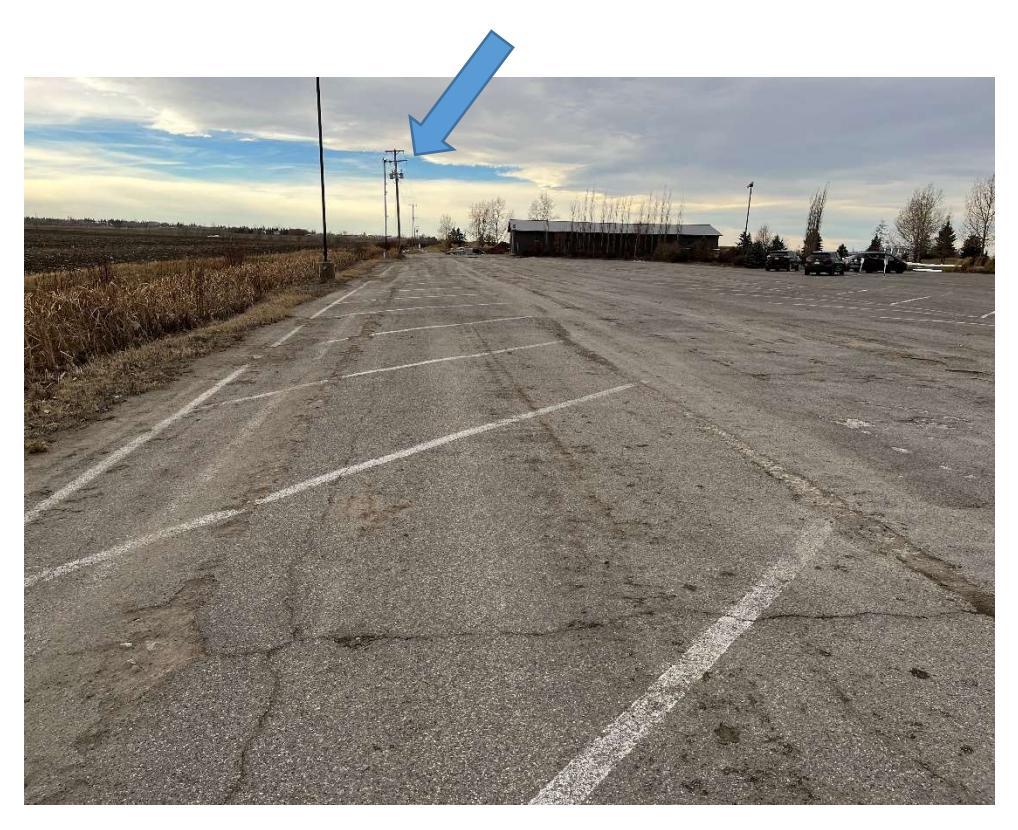
25. View of the pole-mounted transformers (arrow) located on the Olds Golf Course property; (arrow); photograph taken facing west.

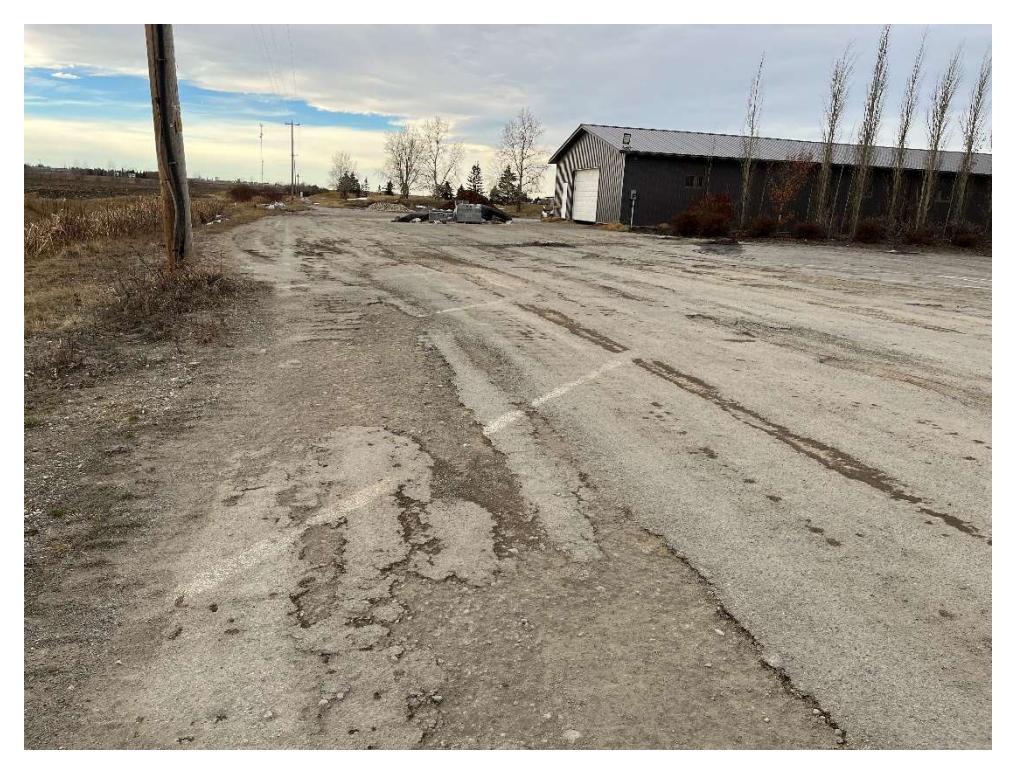
26. View of the golf cart battery charging building; photograph taken facing west.

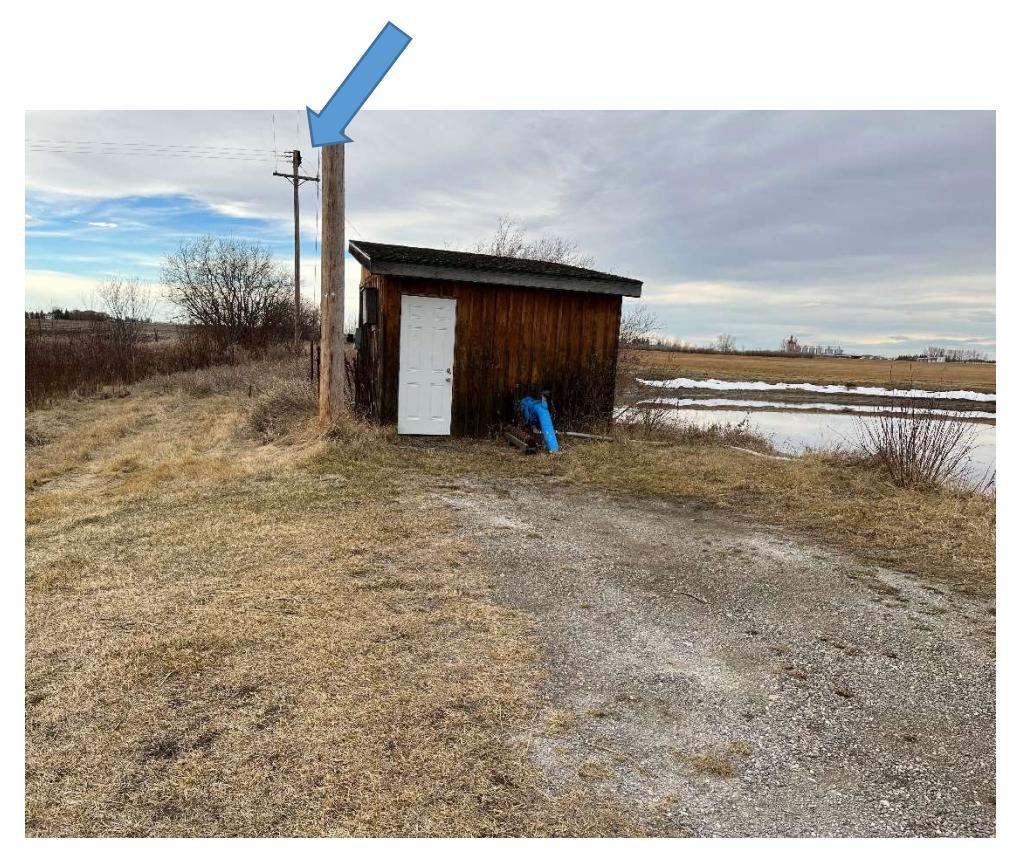
29. Pump house and pole-mounted transformer located on the Olds Gold Course property; photograph taken facing west.

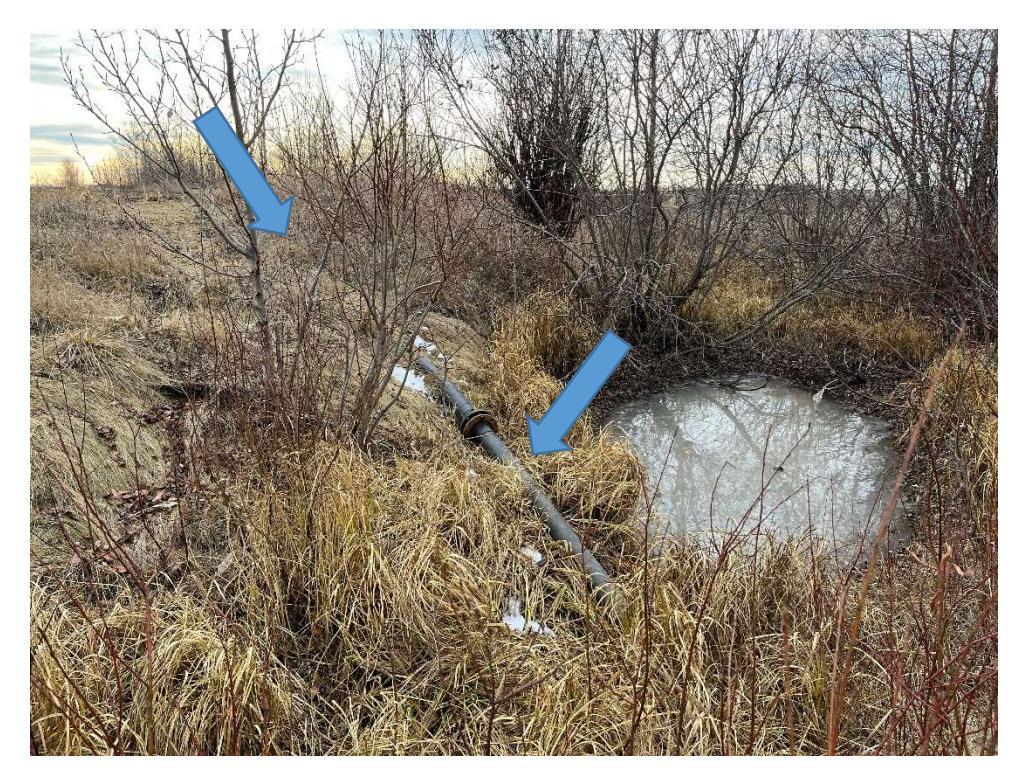
31. Close up view of the pipeline (arrows) leading from the pump house on the Olds Golf Course property; photograph taken facing southwest.

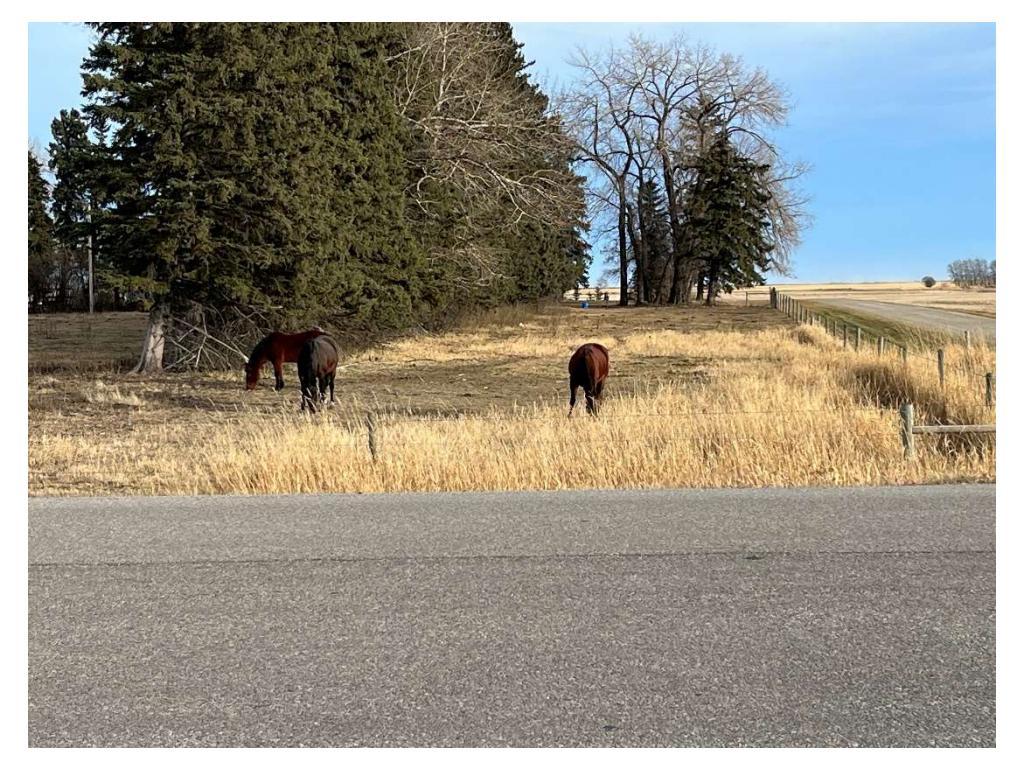
32. View of the farmstead (Location 3) to the northeast of the Project Site; Location 4 can be seen in the background; photograph taken facing east.

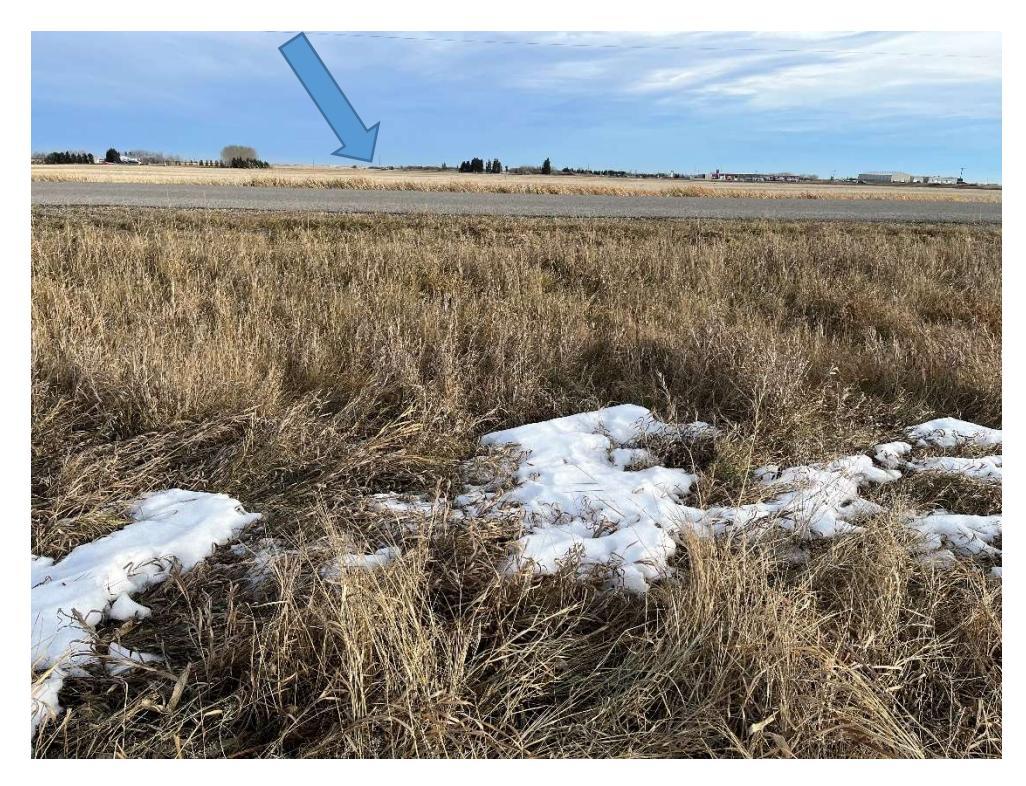
33. View of the agricultural lands associated with Location 5 (arrow), across Range Road 12; photograph taken facing southeast.

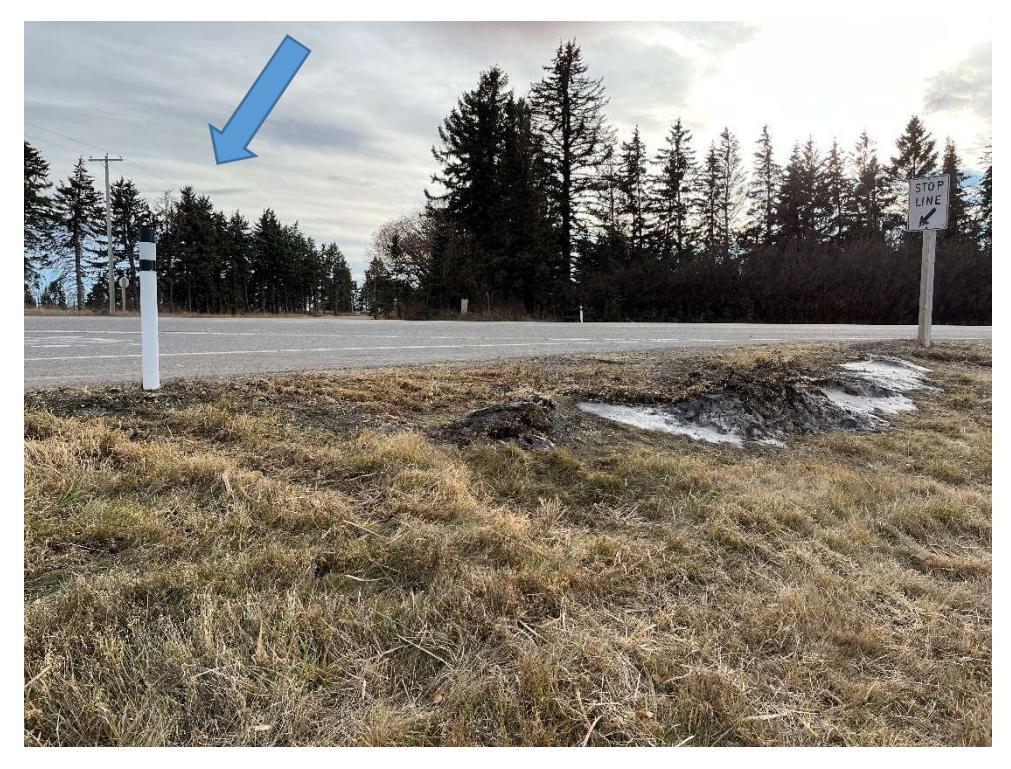
34. View of Location 6 to the southeast (arrow), to the left of the large trees; photograph taken facing south.
