# APPENDIX P

**Environmental and Remediation Services Inc.**

### Photograph Log

RE: Geophyical Surveys at 07-03-033-01 W5 and 08-03-033-01 W5, OLDS, ALBERTA

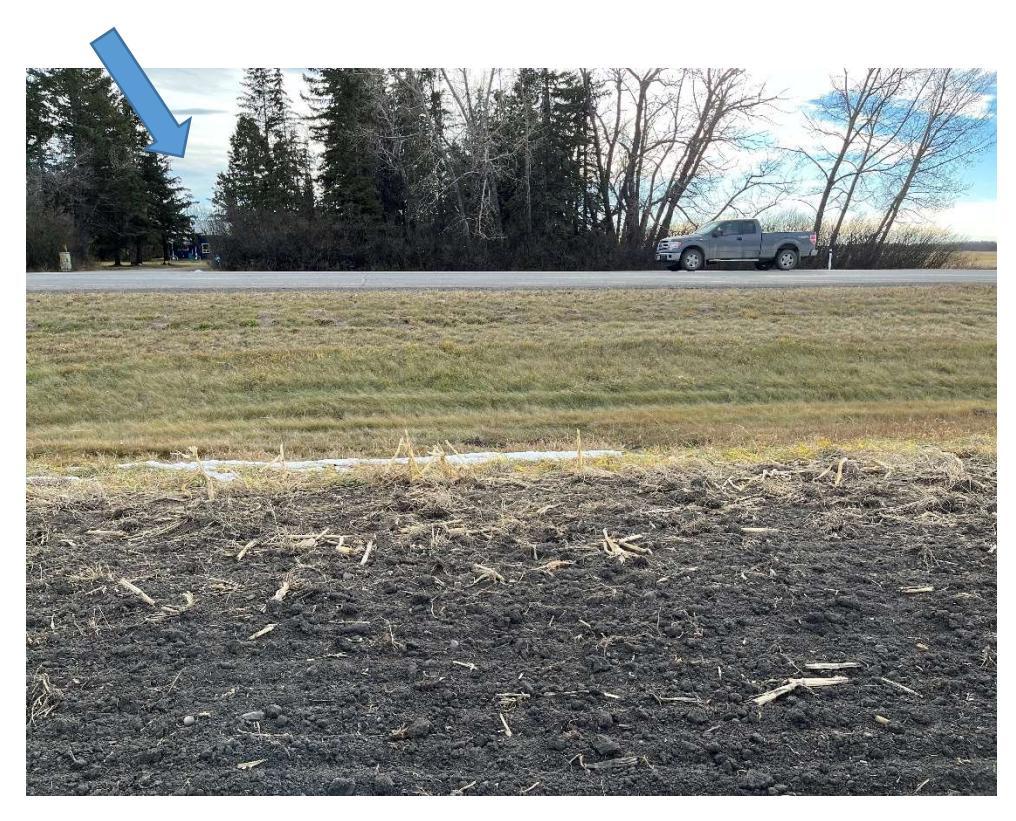
35. View of Location 7 to the south (arrow); photograph taken facing south.

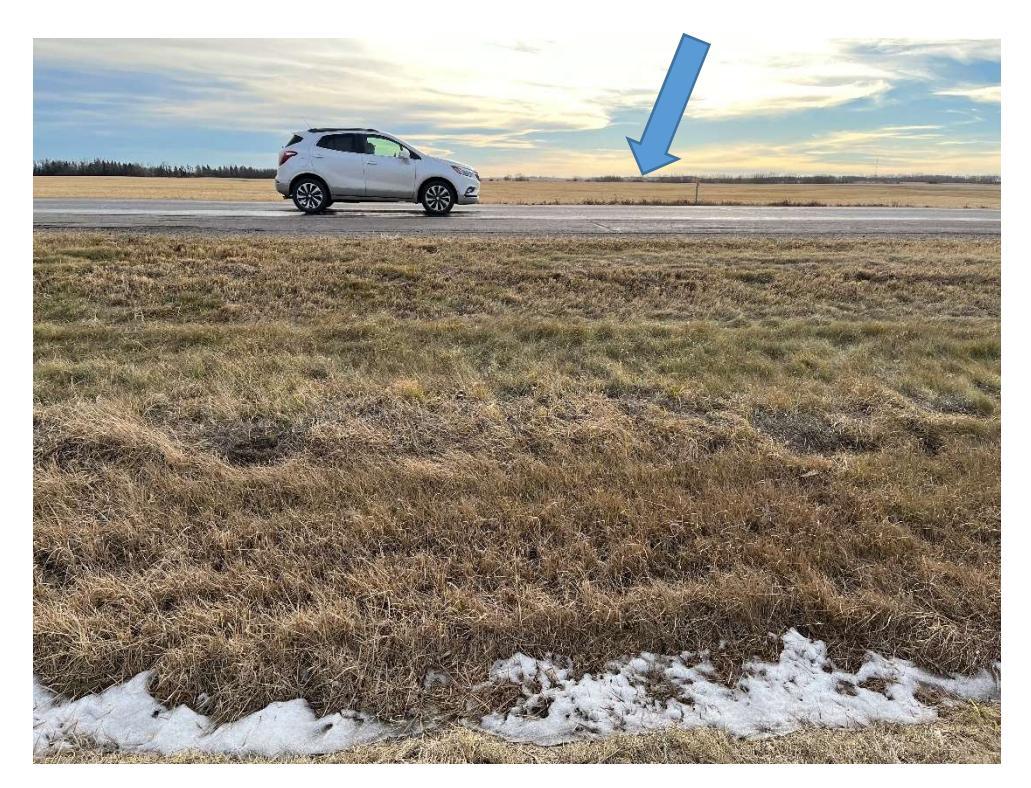
36. View of Location 8 to the south (arrow); photograph taken facing south.

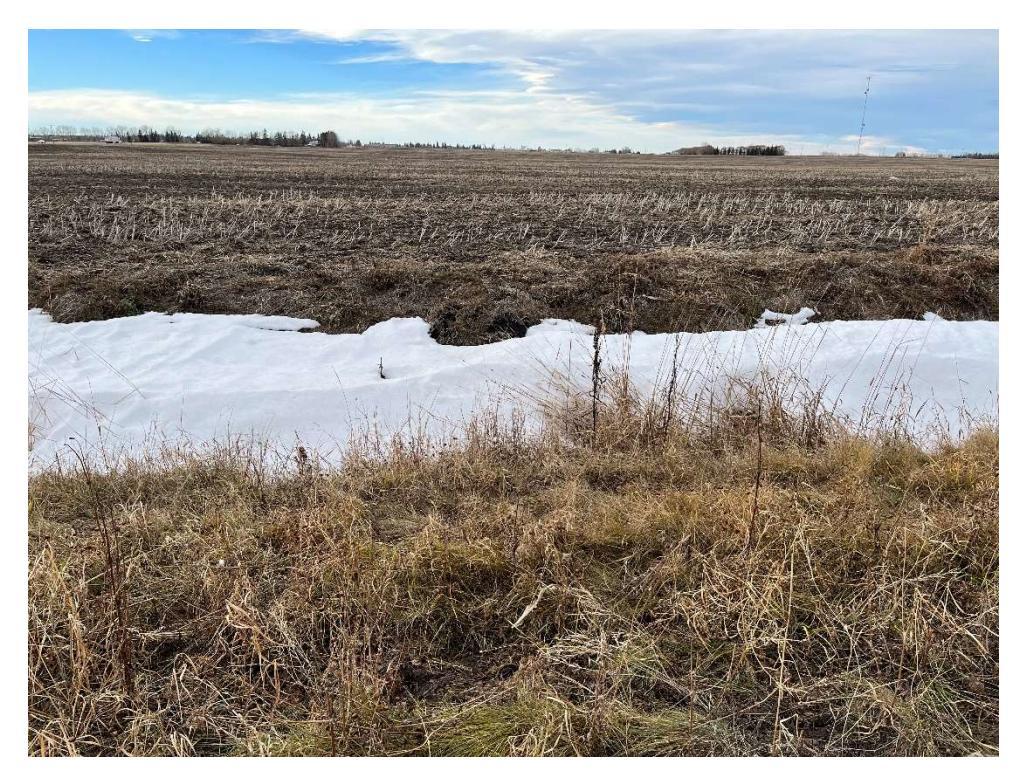
37. View of Location 10 to the west; photograph taken facing west.
